SEVESO
LIST OF RELEVANT ACCIDENTS
AND INCIDENTS

Doc 60.1/25

EUROPEAN INDUSTRIAL GASES ASSOCIATION AISBL

Prepared by AHG 16.1
Published in February 2025

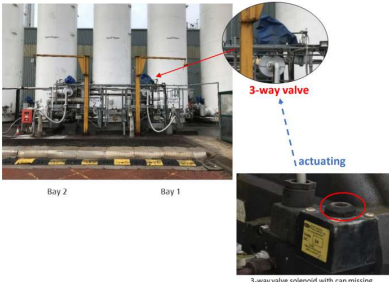
Kind of event that could happen	Example Incidents – Air Separation facility including storage and tanker loading	Key lessons learned	EIGA Doc
	<p>167.05.01 In an ASU at one of the truck loading-bays an unintentional release of 39 t of LOX occurred from a storage tank due to a malfunctioning pneumatic valve. It had been affected by cold rainy and stormy weather. Major release of liquid oxygen. No injuries or further damage caused. [TP INC 43]</p>

<p>Weather protection needs to be regularly checked/maintained.</p>	
<p><u>CONTROL OF MAINTENANCE/REPAIR /MODIFICATION ACTIVITIES</u> Improperly managed modification or repair to (oxygen) process equipment can result in rupture, energy release or spill.</p>	<p>057.06.02 At an air separation plant a gas-return-valve of the filling pump of a low-pressure storage tank was repaired but leakage was found during the tightness test. After venting the system when unscrewing the upper part of the valve liquid oxygen splashed. Operator suffered cold burns. Lost time injury.</p> <p>122.05.04 A worker left a drain valve open when completing a maintenance task on a cryogenic storage vessel. 9 tonnes of liquid oxygen was released, entering the underground sewer system. The sewer was purged with nitrogen.</p> <p>116.03.01 There was a pressure release and fire from a new section of high pressure oxygen pipeline that was being brought into service as part of an upgrade project that had been installed during the recent ASU3 turnaround. 3 people working in the area at the time were affected by the pressure release, all three were referred to the medical centre with no immediate treatment required and returned to site. Subsequently two of these people have received further treatment, one scaffolder identified with a broken rib, and another Scaffolder with a badly sprained ankle. It was determined that the materials of construction for the control valve and check valve were not suitable.</p> <p>111.05.01 During maintenance of the actuator of a cold box LOX valve at an ASU Site, the drive shaft was ejected from the valve body. The result was an escape of a considerable quantity of oxygen which resulted in formation of fog with severely reduced visibility. No injuries or environmental impact. The plant was put into emergency shutdown and had to be warmed up to allow examination of the damaged valve.</p>	<p>Leaks from process equipment and other operational issues should be addressed in a timely manner.</p> <p>Planned and unplanned maintenance activities should be controlled using Lockout Tagout (LOTO), Work Permit and – where relevant - Change Management procedures</p> <p>Equipment for use in oxygen should be clean and only suitable lubricants should be used</p> <p>Operators should wear specified PPE correctly</p>	<p>Doc 04</p> <p>Doc 170</p> <p>Doc 13</p> <p>Doc 147</p> <p>Doc 51</p> <p>Doc 33</p> <p>Doc 40</p> <p>Doc 23</p> <p>Doc 136</p> <p>Doc 146</p> <p>TP 60</p>

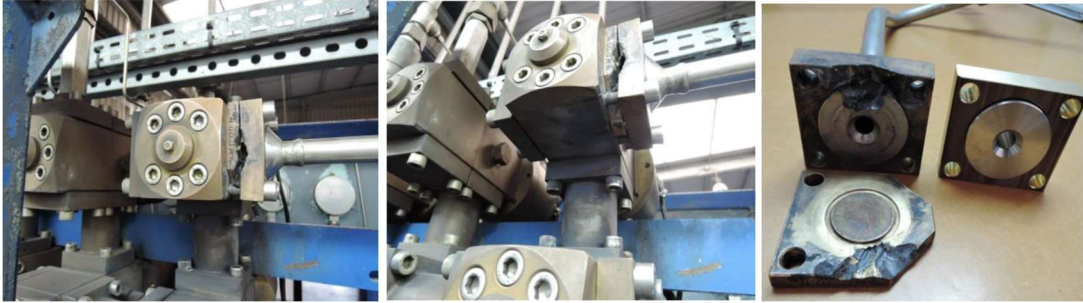
Kind of event that could happen	Example Incidents – Packaged Gases cylinder filling facility (excluding Acetylene)	Key lessons learned	EIGA Doc
	<p>143.13.01 During the filling of medical oxygen an oxygen burn out occurred on the intentionally blocked control valve at the automatic HP control valve built into the valve cabinet. [Photo TP INC 20]</p>

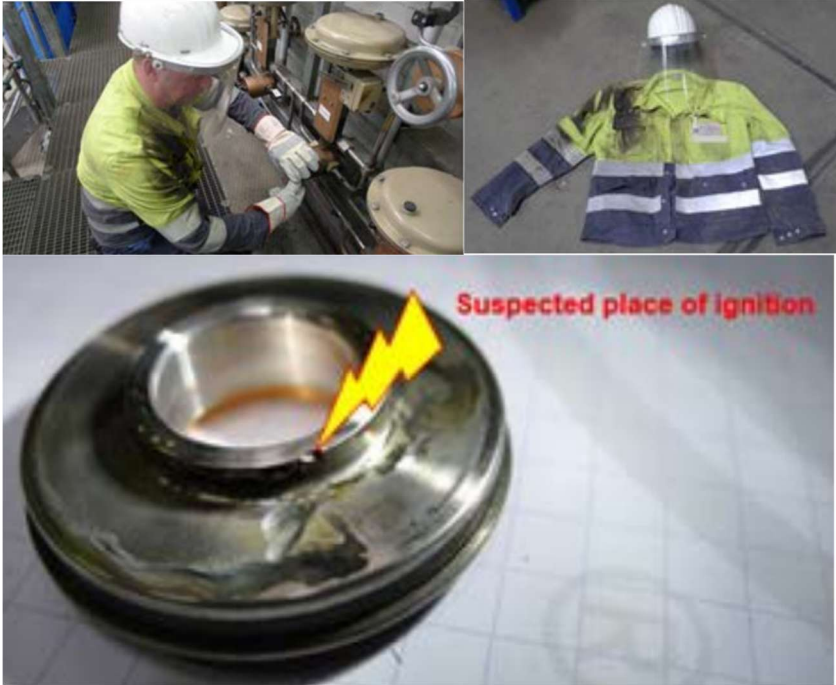
Kind of event that could happen	Example Incidents – Packaged Gases cylinder filling facility (excluding Acetylene)	Key lessons learned	EIGA Doc
	<p>093.05.02: During filling of medical oxygen there was an explosion in one of the filling ramp valves and the flexible hose damaging the equipment and throwing down cylinders. The vacuum pump oil (oxygen approved up to 2 bars) had been sucked back into the high pressure system due to wrong design of the vacuum pump installation and the cylinders and piping system put under vacuum for a very long time.</p> <p>157.03.02: A fire occurred on a 300 bar oxygen filling system. The valve ignited and burned through at the neck thread area causing the cylinder to be ejected from the pallet. It was subsequently propelled upwards landing on a mezzanine platform. Fire service were called and the localised fire was extinguished within 1 hour.</p> <p>157.02.03: After completing the filling of 300 bar oxygen cylinder bundles, the employee wanted to depressurize the system. To do this, he opened the corresponding manual valve. The valves on the cylinder bundles were already closed (final filling pressure: 340 bar). When the valve was opened slowly, oxygen burnout occurred in the area of the valve and the downstream pipelines at approximately 320 bar GOX pressure. At that moment, the employee was crouching diagonally to the left in front of the valve.</p> <p>The flash fire burnt the GOX pipe and the flame injured the employee's neck and face as the flash-fire blew the helmet and face-protection mask off his head, the helmet was not fixed. The employee suffered from burned skin grade 1 and 2 on his neck and in his face. He was able to close the valve from the side from a safe position and thus stop the flash fire. [Photo TP INC 33]</p>

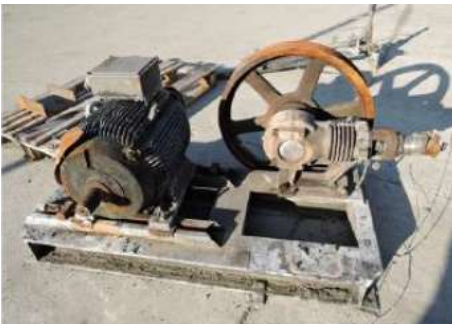
Kind of event that could happen	Example Incidents – Packaged Gases cylinder filling facility (excluding Acetylene)	Key lessons learned	EIGA Doc
	<p>» not optimal pump-tank installation. The pump was operating, at least partially, below the minimum NPSH [Net Positive Suction Head pressure].</p> <p>»lack of preventing creation of moisture and/or ice on the piston.</p> <p>»improper operation and pump maintenance. [Photo TP INC 19]</p>

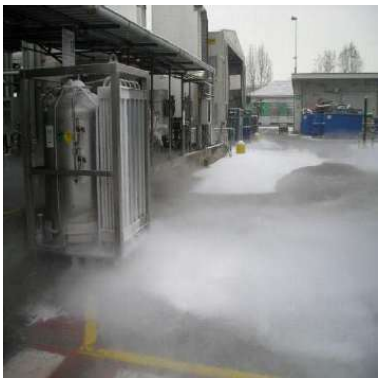
Kind of event that could happen	Example Incidents – Packaged Gases cylinder filling facility (excluding Acetylene)	Key lessons learned	EIGA Doc
	<p>126.07.01 The lower piping of a of a vaporiser was ruptured when contacted by a forklift resulting in an 800-liter product leak. After filling the oxygen micro bulk (integrated cryogenic vessel and vaporiser), the forklift approached to move it to the storage area with its forks in the incorrect position above the fork housing. As the vehicle moved forward it broke the lower piping of the vaporiser causing the complete leakage of product. The driver reversed the forklift into a safe position immediately and the area was sprayed with water. Lack of adequate protection against forks striking equipment was detected. [Photo TP INC 3]</p>

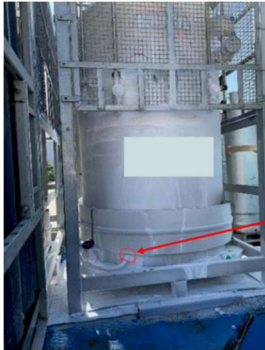
<p>161.05.01: When delivering full products and picking up empty cylinders, a customer operated FLT punctured a full oxygen pallet-tank pipe by the forklift forks. The pallet-tank was on the truck-bed when the FLT attempted to unload an empty bundle. [Photo TP INC 37]</p>

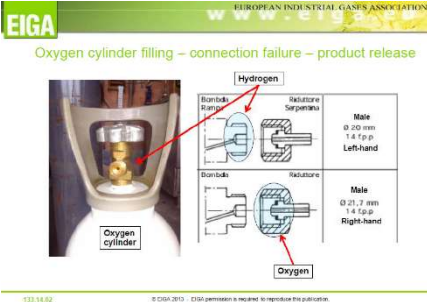
Kind of event that could happen	Example Incidents – Packaged Gases cylinder filling facility (excluding Acetylene)	Key lessons learned	EIGA Doc
	<p>094.03.01: A fire occurred in the SiH4 filling room as a result of a leak suspected to on the cylinder fill rack between the nipple connector and the cylinder valve. The fire caused significant damage to building and equipment.</p> <p>133.14.02: During the first filling of a 14 litre customer owned oxygen cylinder, when pressure reached 100 bar, the filling hose suddenly disconnected and whipped, because valve and hose threads did not match. A partial forced connection was possible because the diameter of the valve was slightly less than that of the filling hose. [Photo TP INC 10]</p>

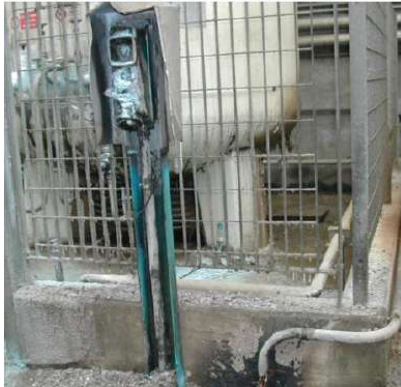
Kind of event that could happen	Example Incidents – Vacuum Jacketed tanks and cryogenic tankers	Key lessons learned	EIGA Doc
<p><u>MECHANICAL IMPACT</u> damage to piping or tank can cause loss of containment</p>	<p>050.04.04 Whilst lifting out a liquid oxygen vaporizing coil for a planned inspection, the mobile crane became unstable and toppled approx. 45° striking a LOX storage tank inlet valve spindle. Storage tank fractured.</p> <p>133.11.01 Customer Unit- Oxygen supply– Pipework from a liquid vessel at a customer site failed primarily as a result of its burial depth being too shallow and it being regularly passed over by heavy vehicles. This resulted in a pipework break with resultant loss of supply, pressure release at break point, and flash fire at electrical junction box occurred during a driver delivery; a 0.5 metre section of subterranean pipe was consumed in the subsequent oxygen-fed fire. The driver correctly isolated the system, then escaped, but fell as he ran from the incident, resulting in minor injuries. [Photo TP INC 11]</p> <p>074.07.04 An oxygen flash occurred when a contract driver was attempting to tighten a hose connection fitting with a hammer on an asphalt surface soaked with liquid oxygen. Driver suffered 2nd degree burns to his face</p>

<p>Lifting operations should be properly planned and managed by competent personnel</p> <p>Design of installations should consider vehicle traffic in the vicinity</p> <p>Asphalt should not be used near liquid oxygen installations</p> <p>Personnel should be competent in filling operations</p>	<p>Doc 224</p> <p>SI-HF 02</p> <p>Doc 04</p> <p>Doc 23</p>

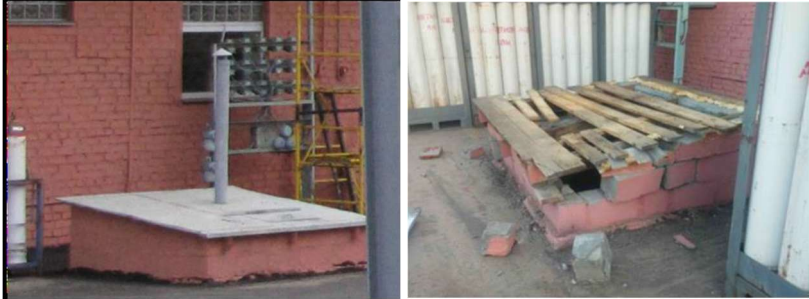
Kind of event that could happen	Example Incidents - Acetylene	Key lessons learned	EIGA Doc
	<p>147.05.01 After draining water/oil emulsion from acetylene compressors, a decomposition occurred in the waste water/oil collector -pit. Collector pit was damaged, and cover destroyed. Nobody was hurt. [Photo TP INC 24] Photographs show pit before and after event</p>

<p>pipework should be controlled using Lockout Tagout (LOTO), Work Permit and – where relevant - Change Management procedures</p>	
<p>FORMATION OF ACETYLIDES If acetylene is exposed to copper, silver or mercury, it forms an acetylide compound, which is highly explosive.</p>	<p>042.05.02 An explosion occurred in the piping between the acetylene compressor and the downstream acetylene dryer. A copper blind plate had been forgotten and caused a reaction to copper acetylide and explosion. No injury. Piping, compressor and dryer damaged. Rooms and technical equipment damaged.</p> <p>053.05.02 At a customer's premises a pipeline for acetylene was made from copper. No injury or damage but potential danger that acetylene and copper react to copper acetylide, which is a highly explosive substance.</p>	<p>Copper, silver and mercury should be excluded from acetylene plant and customer installation designs.</p> <p>Arrangements should be established during maintenance to prevent copper, silver and mercury being brought onto the acetylene plant.</p>	<p>Doc 123 Doc 212</p>

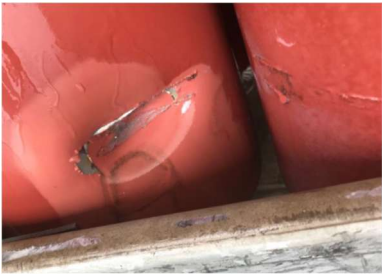
Kind of event that could happen	Example Incidents - Acetylene	Key lessons learned	EIGA Doc
<p><u>MECHANICAL IMPACT FROM VEHICLES</u> Mechanical impact from in-plant or other vehicles can cause damage to valves, accessories or piping on cylinders, bundles, vessels or installations, resulting in a product release.</p>	<p>157.14.05 A forklift hit an acetylene bundle with the forks, causing a crack and leakage of acetylene and acetone. There was no ignition and no consequences for people/environment [Photo TP INC 33]</p> <div style="display: flex; justify-content: space-around;">

</div>	<p>Fixed installations should be provided with protection against vehicle impact.</p> <p>Drivers of forklift trucks should be competent and authorised</p> <p>A Traffic plan should be in place.</p>	<p>Doc 165</p> <p>SI 21</p> <p>SI 25</p> <p>SI-HF 02</p>
