Most cases of asphyxiation take place in confined spaces, such as process vessels, cold boxes, totally enclosed working areas and pits. However, asphyxiation can occur in the open air as demonstrated by a number of accidents reported to EIGA. The purpose of this Newsletter is to draw to the attention of operators working with industrial gases the dangers of asphyxiation when working in the open air.

1. Asphyxiation fatalities on a construction site

2. Asphyxiation near-miss accident in the open air

3. Contractor affected by CO₂ in open air

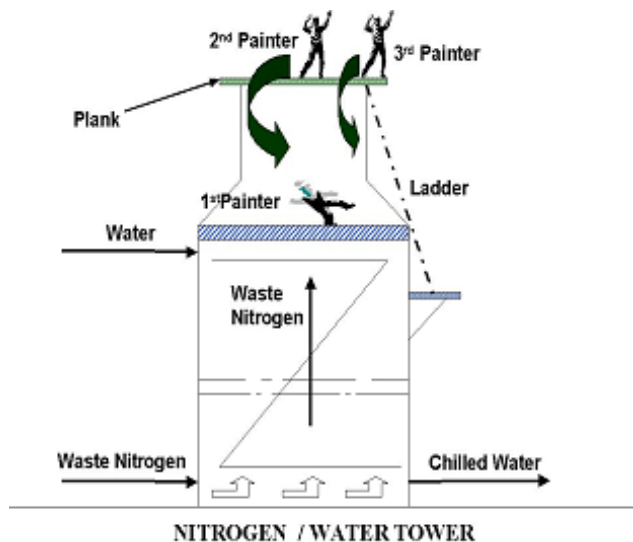
Figure 1

During the commissioning phase of a new air separation unit (ASU), prior to the mechanical completion of the plant, three subcontract employees were killed while working on a waste nitrogen tower.

- Three painters from a subcontractor were working to complete external painting works on a waste nitrogen / water tower while the plant was being started up
- To complete the painting of the top tower section a wooden plank was put across the exhaust section to atmosphere.
- One painter climbed on the plank, was overcome by the surrounding nitrogen stream and fell inside the tower.
- The two other painters rushed from the ladder to the plank to rescue their colleague.
- Both collapsed into the tower as well.
- The three painters died before they could be rescued.

- Safe systems of work are required at all times.
- Specific hazard controls are required during plant start up
- Need of clear definition of responsibilities between all parties involved in construction / commissioning phases

- Hazards to be identified and communicated to contractors and sub-contractors workers
- Use of identification / warning signs against asphyxiation hazards or potential hazards from equipment in operation
- Need of appropriate training

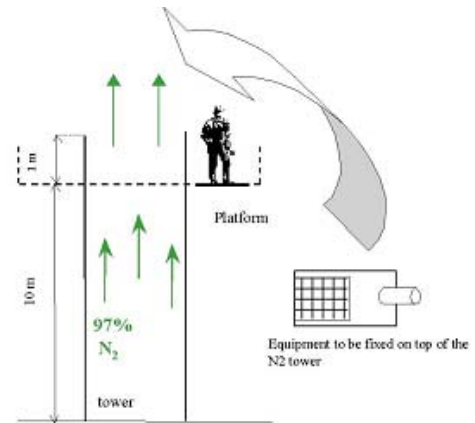
Figure 2

The project consisted of installing equipment to enable the diversion of the out flow from a nitrogen tower (see figure 2). The work was carried out on a platform 10 metres above ground, the equipment being lowered by crane onto the top of the nitrogen vent. Two contractors were working on the platform together with a supervisor who was in radio contact with the crane operator. A work permit was prepared, the operators were trained and wearing portable oxygen monitors.

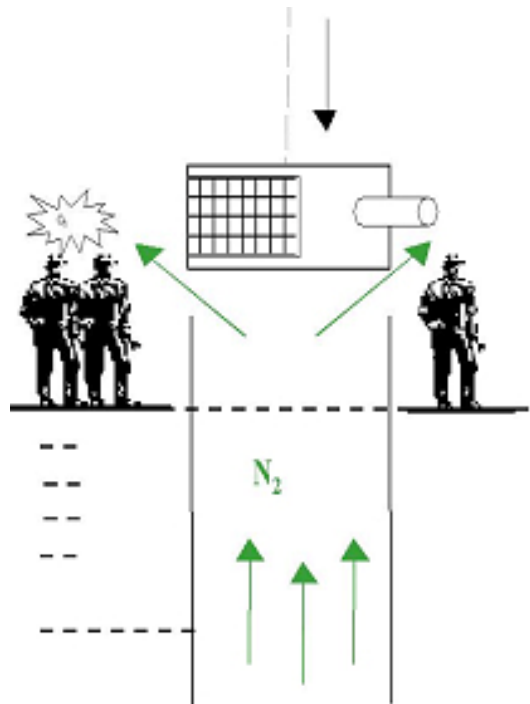
Figure 3

- One of the workers lost consciousness and the second worker who went to assist his colleague also collapsed;
- As the equipment was lowered into position the nitrogen was diverted onto the platform, (see figure 3);
- The oxygen monitors showed the lack of oxygen;
- The supervisor realised what was happening and instructed the crane operator to raise the equipment;
- The oxygen concentration quickly returned to normal and the workers recovered without any permanent effects.

- Safe systems of work are required at all times;
- Appropriate training for the operators to increase the sensitivity to works in elevated situation together with a risk of asphyxiation;
- Prepare an efficient emergency plan;
- Unless the N₂ emission can be stopped, operate with a self-contained breathing system in the risk areas;
- Use personal oxygen monitors as identified by risk assessments when planning the work.

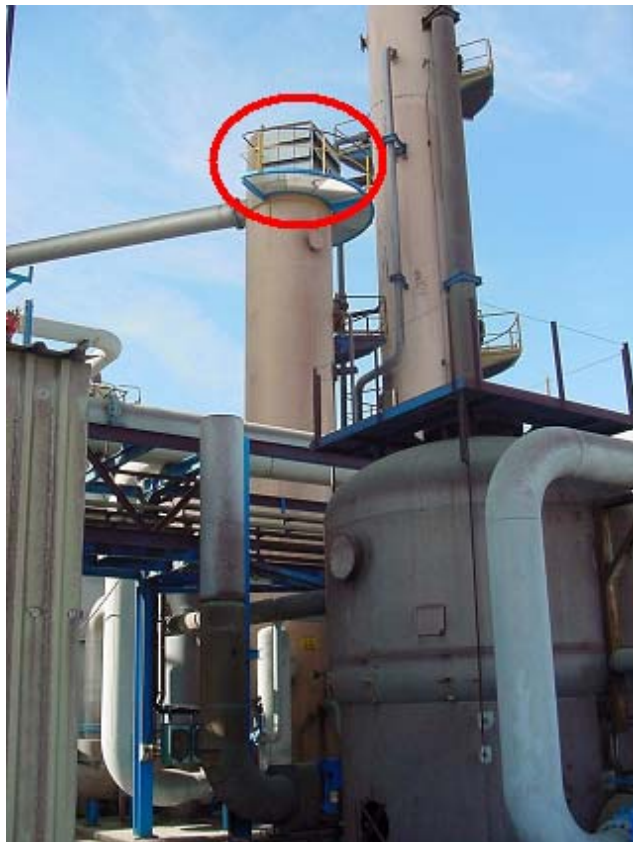
Figure 4: The tower after completion of the work

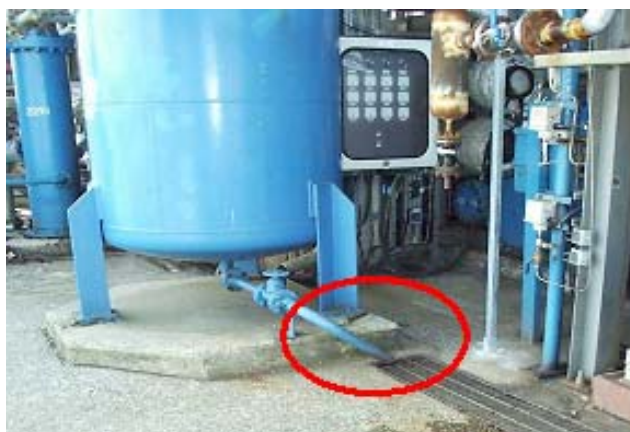
An electrical contractor was working in an open area fitting a cable ducting when he developed breathing difficulties and turned blue in the face (see fig. 5). He stood up and staggered backwards. His colleagues took him to the control room where he slowly recovered. He was taken to hospital where he made a full recovery and was released after a few hours.

Weather conditions were blustery and the work was being carried out in the open air in a freely ventilated area. However, a catch pot drain was permanently cracked open to give a continuous vent of CO₂ and the work involved the electrician's face being within 0.5 metres of the outlet. Measurement subsequent to the incident indicated an oxygen concentration of 15.8% close to the drain. This oxygen concentration means that the CO₂ constituted about 25% of the air – a level which can be fatal.

- Unlike other common asphyxiant gases, CO₂ has toxic and damaging effects on the body at high concentrations. When the CO₂ concentration exceeds 10% in air, a fatal risk exists even though the resulting oxygen concentration at 19% would otherwise be considered relatively safe. For this reason, where CO₂ exposure is likely, it is always necessary to use a CO₂ monitor to get a true measure of the risk.

- The managers on site were aware of the continuous venting of CO₂, but given that these vents were in the open, they were not perceived as a hazard.
- During the planning prior to issuing the permit, there was not a realisation that the electrician would be placing his head dangerously close to the vent.

Figure 5 The site of the incident; with the vent red ringed

- The contractor was not familiar with the plant or the product, so he did not realise he was at risk.
- The practice of venting CO₂ in this way is to be reviewed.

- A card advising personnel of the hazards of CO₂ is to be issued.
- If the vents are retained, they will be closed off prior to any work being undertaken in the vicinity.
