Safety Information **Awareness Package**

Events at Customer Premises

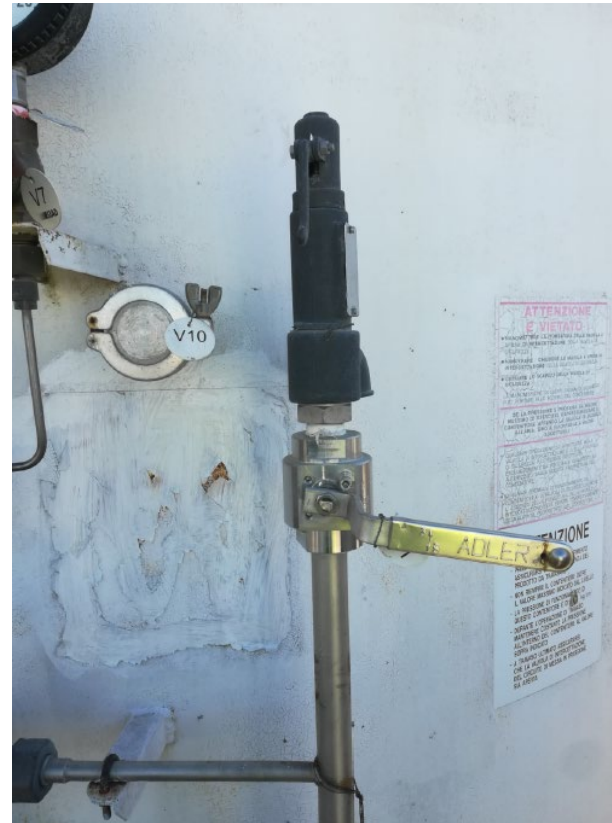
Customer tank - Override of safety devices - Near miss

- The technical operator, who went to the customer for routine maintenance, found the shut-off valve upstream of the safety valve - that protects the nitrogen tank - closed. The internal pressure of the tank was 18 bar (max working pressure 15 bar). The customer voluntarily broke the safety seal to close the valve.
- Near miss.
- Discussion points:
 - Never override or disable critical safety systems (for example safety valves).
 - In case of doubts, contact the gas supplier.

Picture of the reported event showing the manual valve in closed position.

Safety valves shall always have an open connection to the tank!

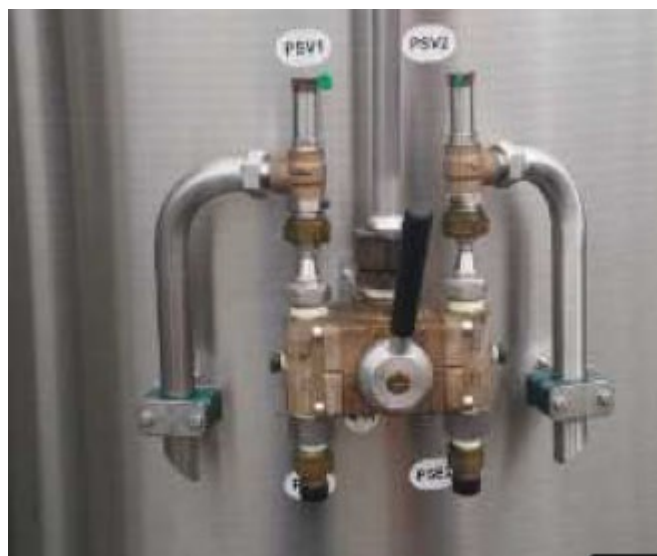
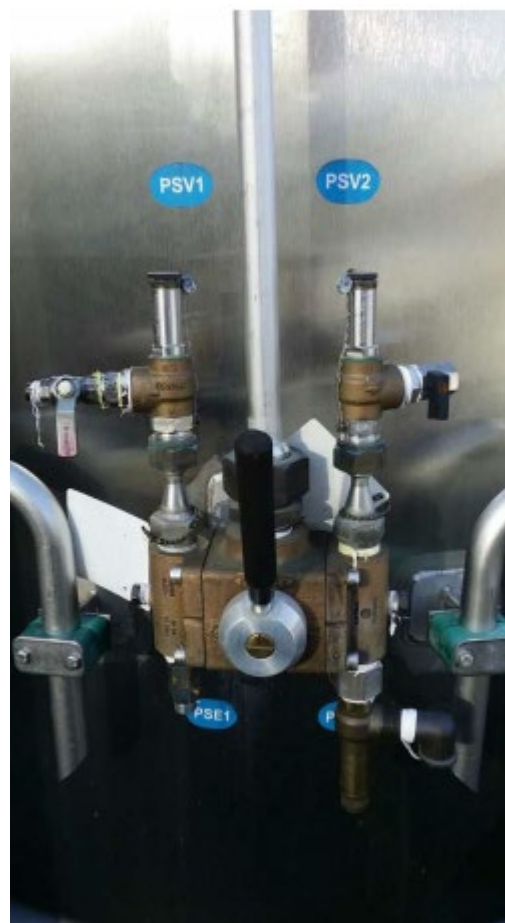
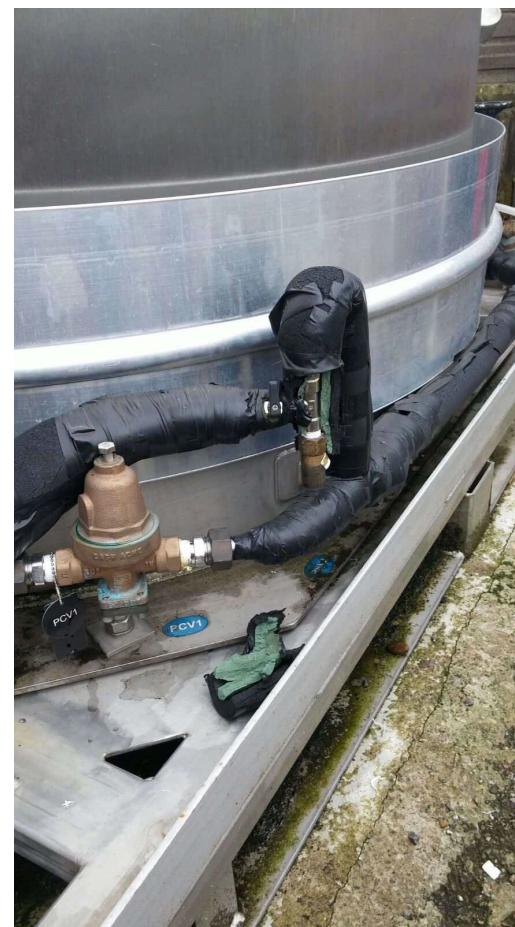
Customer site – Override of safety devices - Near miss

- At an industrial customer the bulk distribution driver found a liquid carbon dioxide installation with safety valves and bursting disks completely plugged.
- The driver identified the defect and risk and refused to fill the vessel.
- Discussion points:
 - Never override or manipulate safety devices
 - Always stop the work if it is not safe to proceed
 - In case of doubts, contact the gas supplier

ball valves were installed on the outlet of the PSVs in such a way that safety valves can be made inoperable

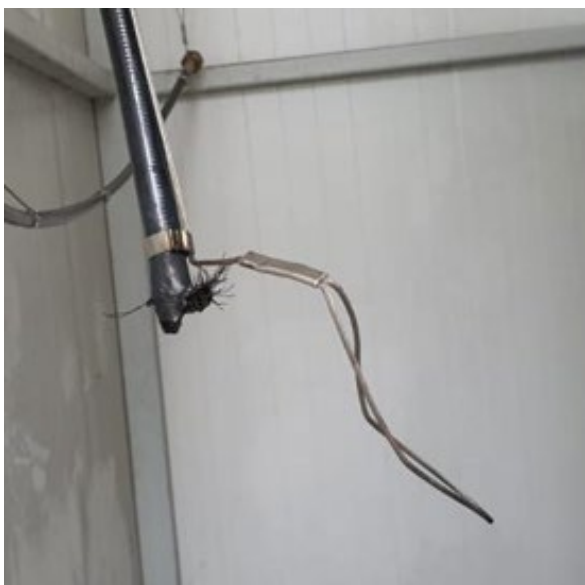
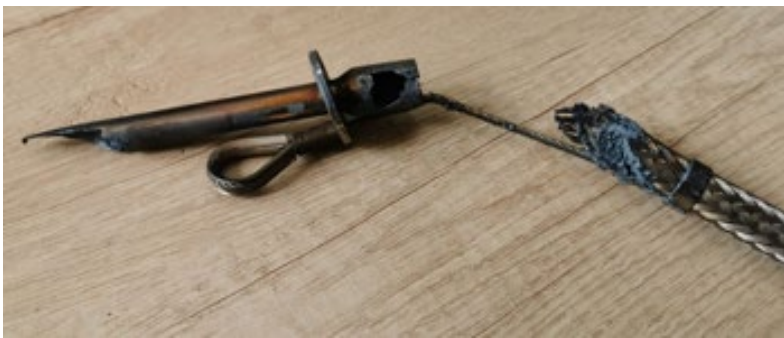
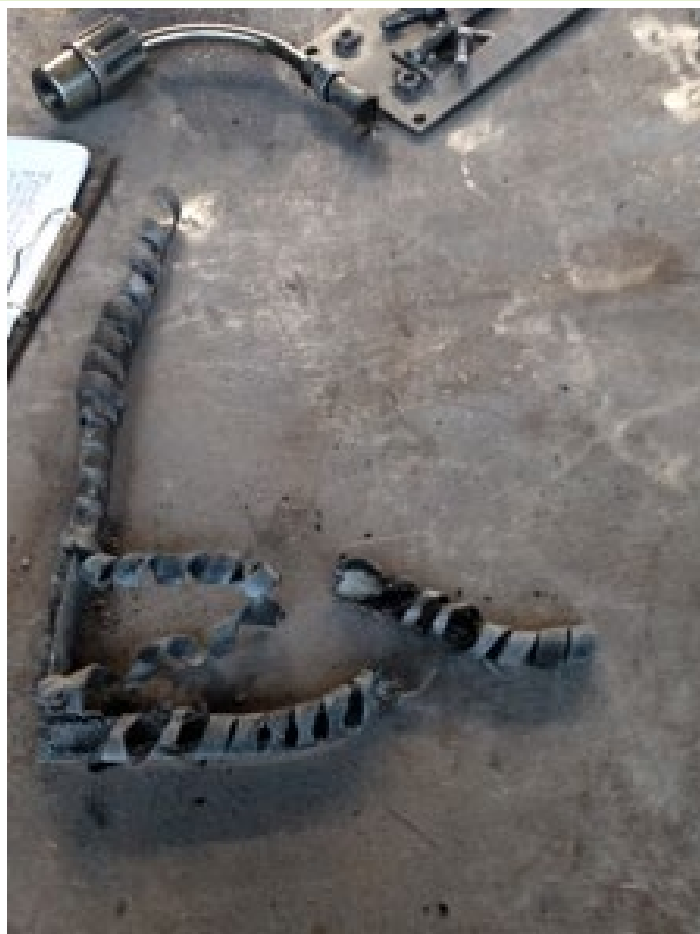
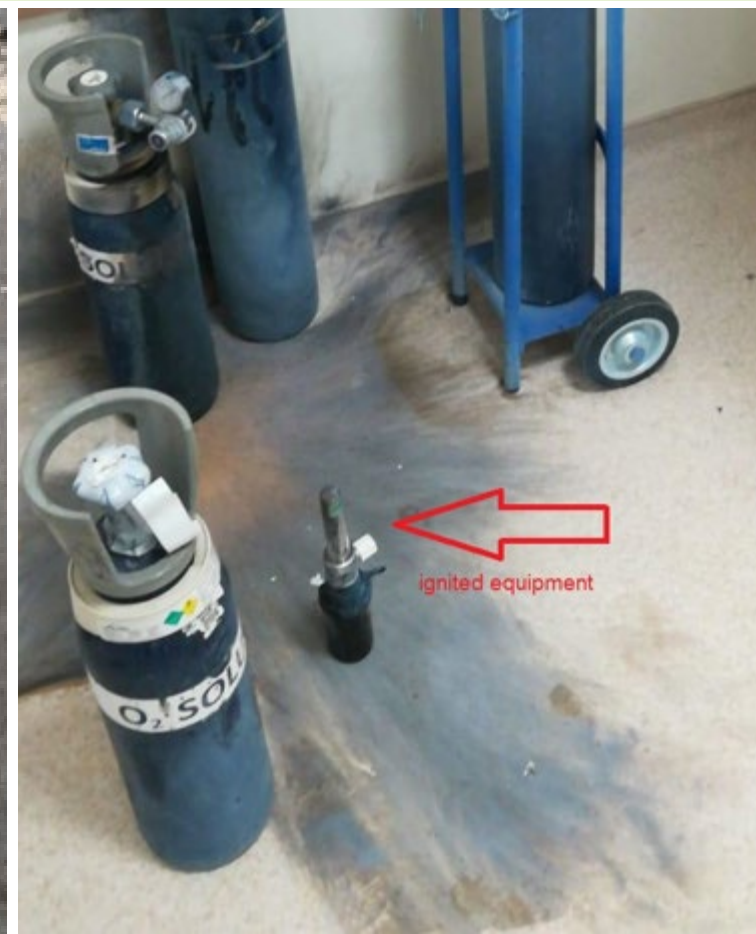
Customer site – compatible replacement of oxygen equipment

- Gas suppliers have often seen incidents after replacement of equipment by the customer with non-compatible parts. The majority of such cases are related to oxygen supply installations, and more specifically oxygen hoses and pressure regulators which have resulted in oxygen ignitions.
- Discussion points:
 - When supply line equipment for oxygen needs replacement, it is of utmost importance to choose oxygen compatible spare parts.
 - In case of doubts, contact the gas supplier that can provide information for a safe change.
 - Any replacement or addition of components should be aligned between the customer and the gas supplier.

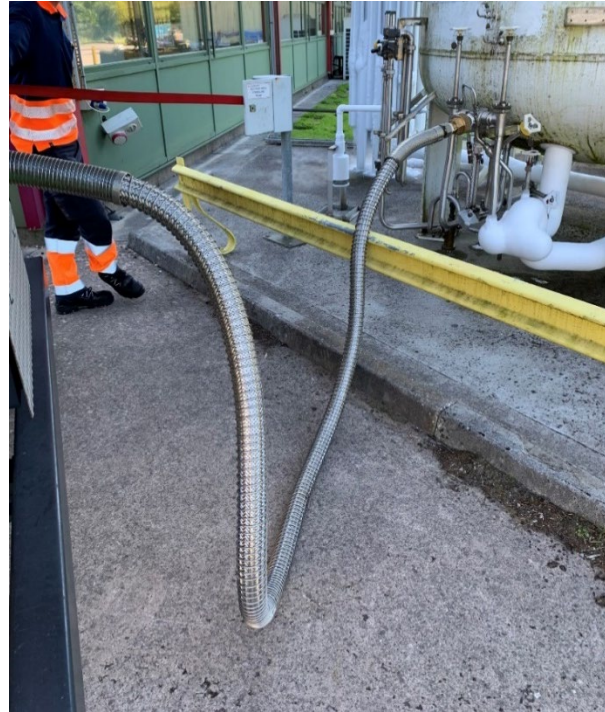
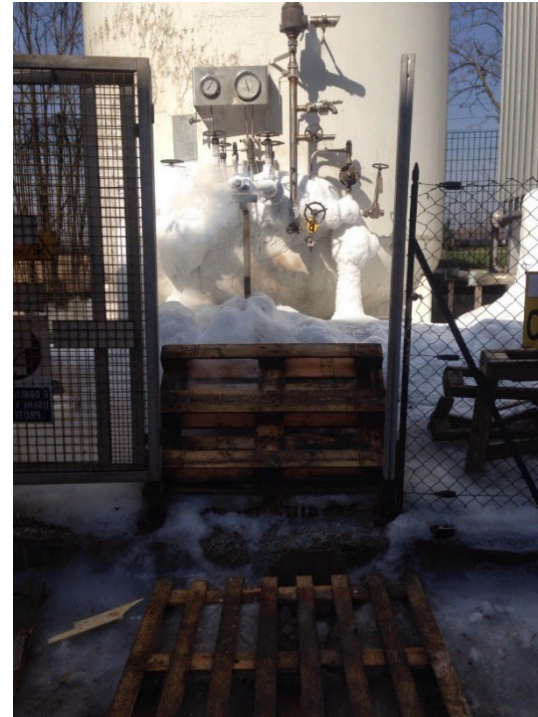
Customer Site - Driver Fall - Injury

- Drivers making liquid deliveries to customers encounter different situations. Those regularly pose a risk for trips and falls that may result in injuries. Examples of these situations:
 - Barriers to step over to get to the valves that need to be operated
 - Materials left around unattended
 - Bad pavement conditions
- Discussion points:
 - Ensure proper design of access
 - Keep the area clean and accessible

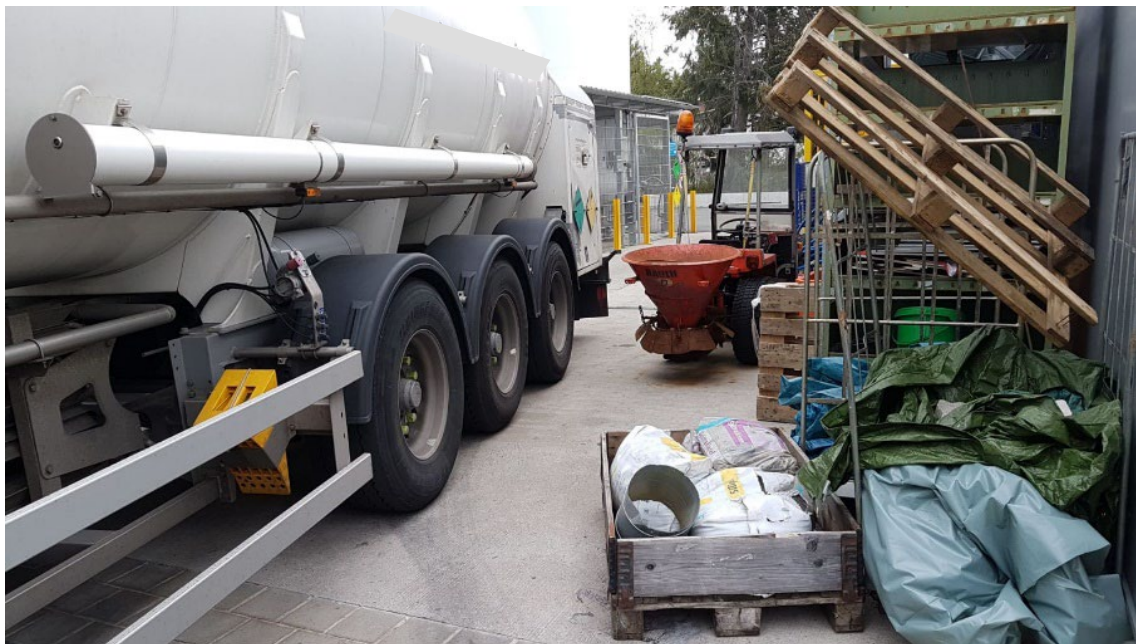
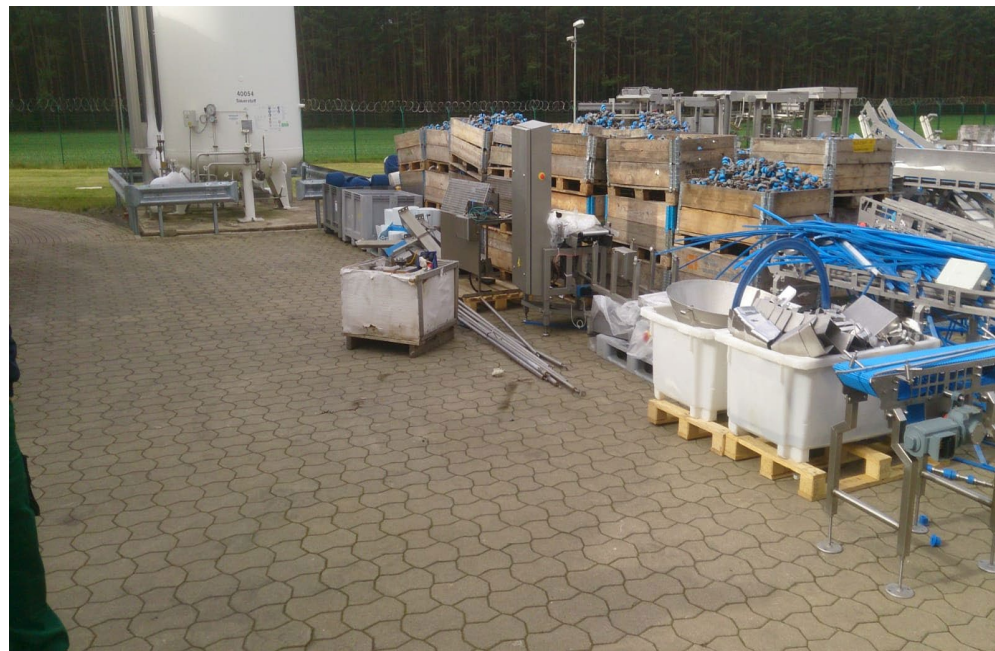
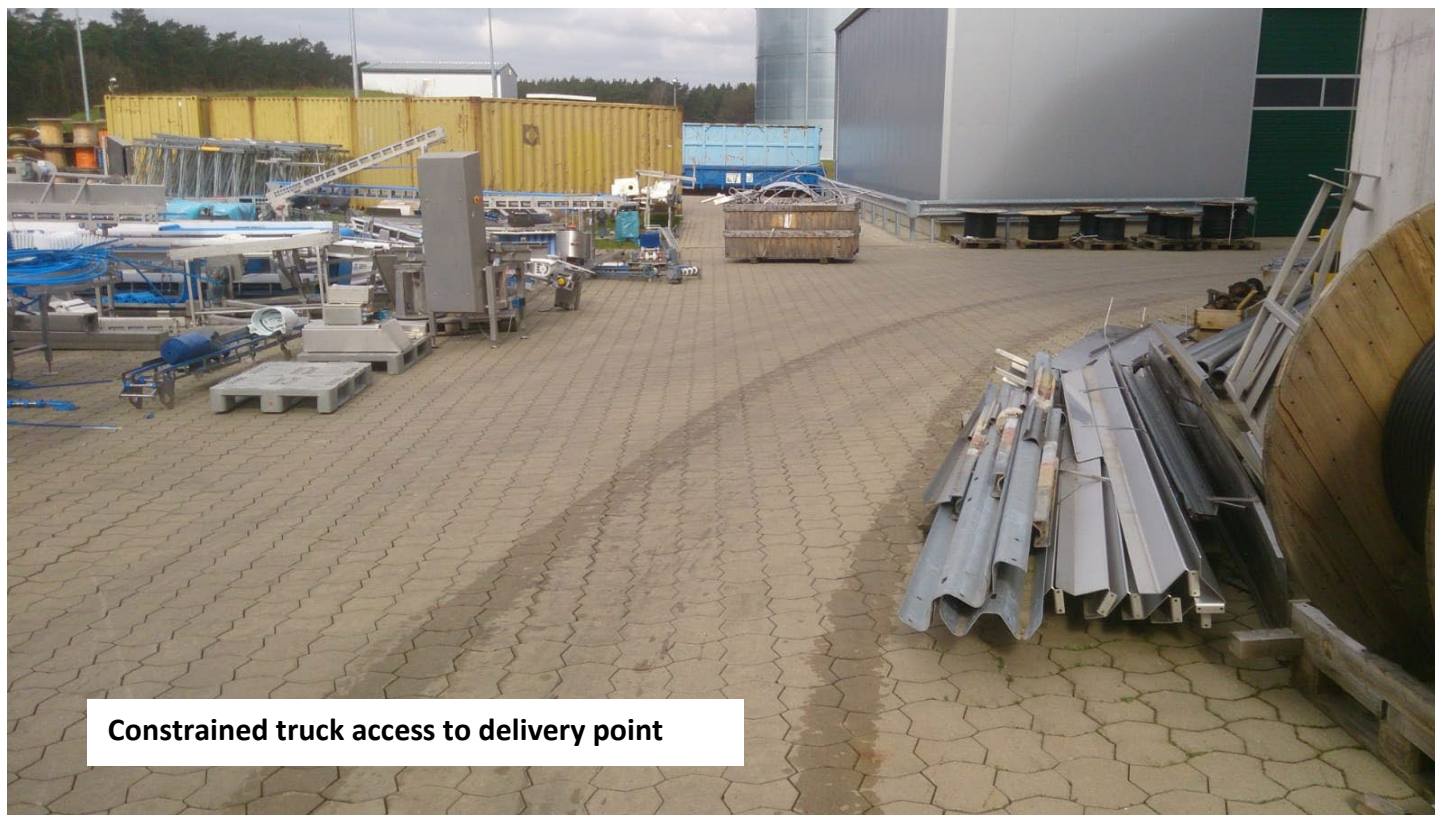
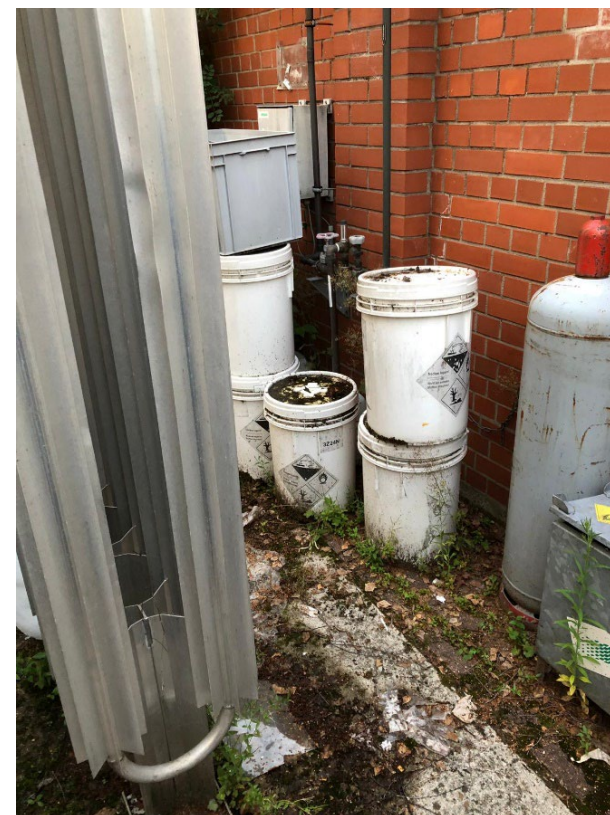
Customer Site – Bad housekeeping

Load of trip hazards close to the vessels; Unloading area is risky to access

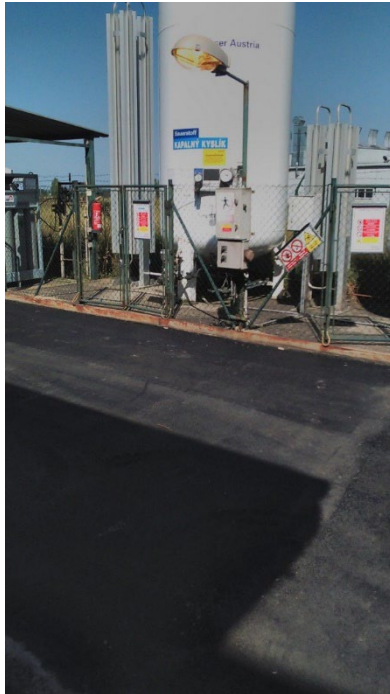
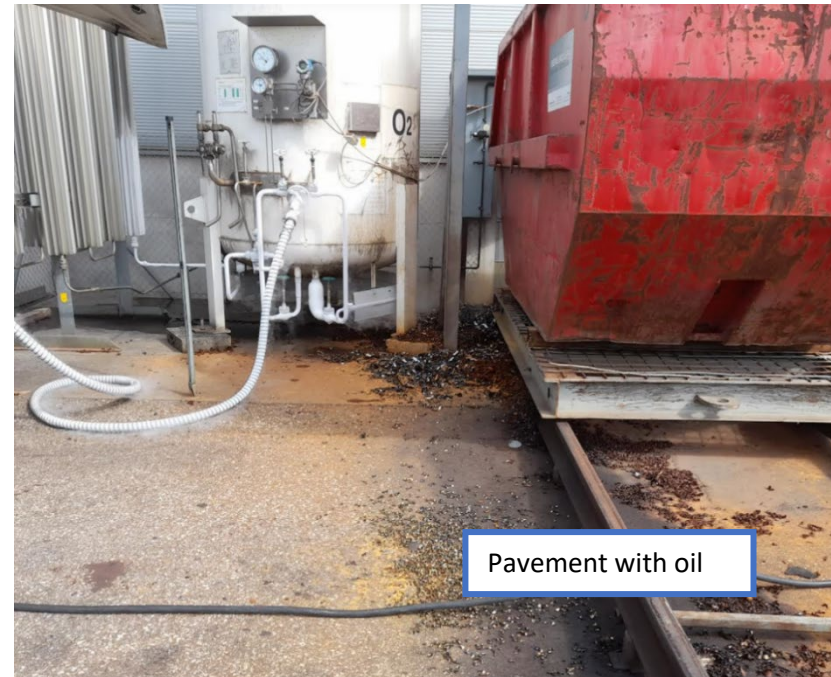
Examples of poor design of installations and maintenance

- Contractor driver was delivering LOX to the customer when he noticed that customer had put new asphalt on the vehicle unloading bay. Asphalt can ignite in the presence of oxygen. He informed the gas company about the change at the customer site and the customer about the hazard.
- Gas company formally informed the customer and stopped the LOX delivery. The customer replaced the asphalt in the LOX transfilling area with concrete.
- Discussion points:
 - Follow the safety requirements defined for installations as specified by gas company
 - In case of doubts, contact the gas supplier
 - Notify any change to the gas company for alignment

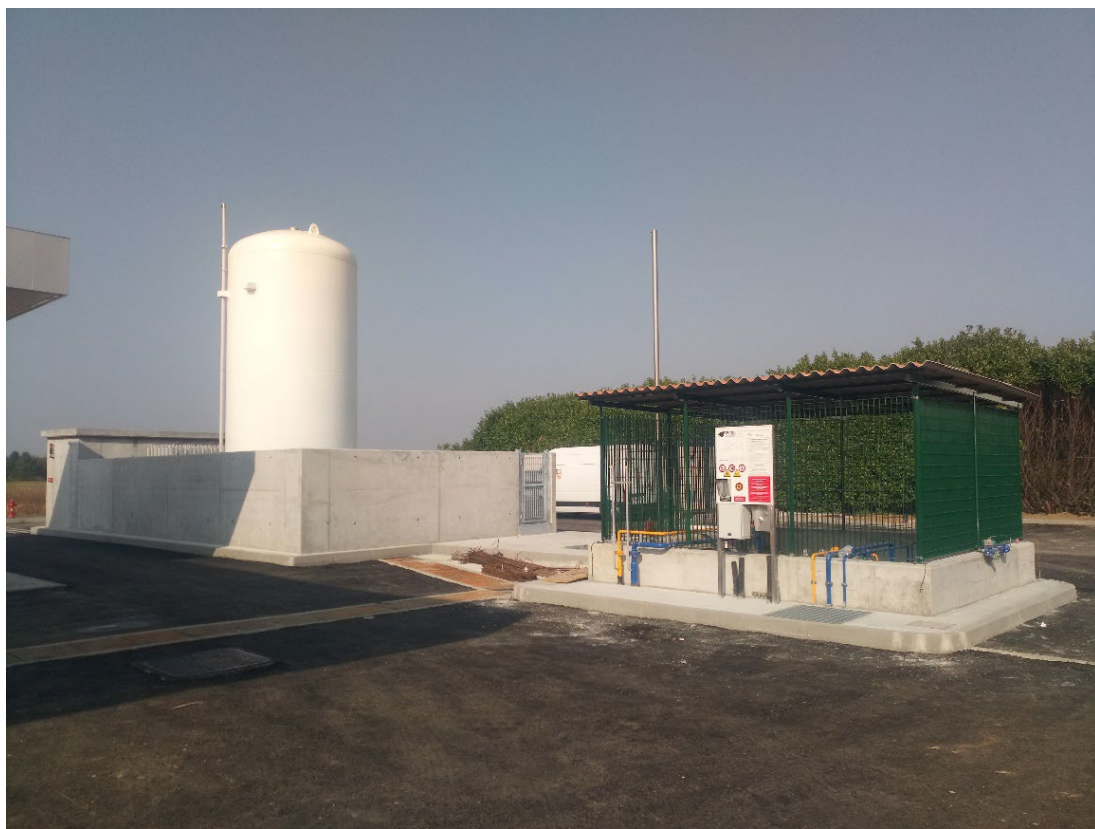
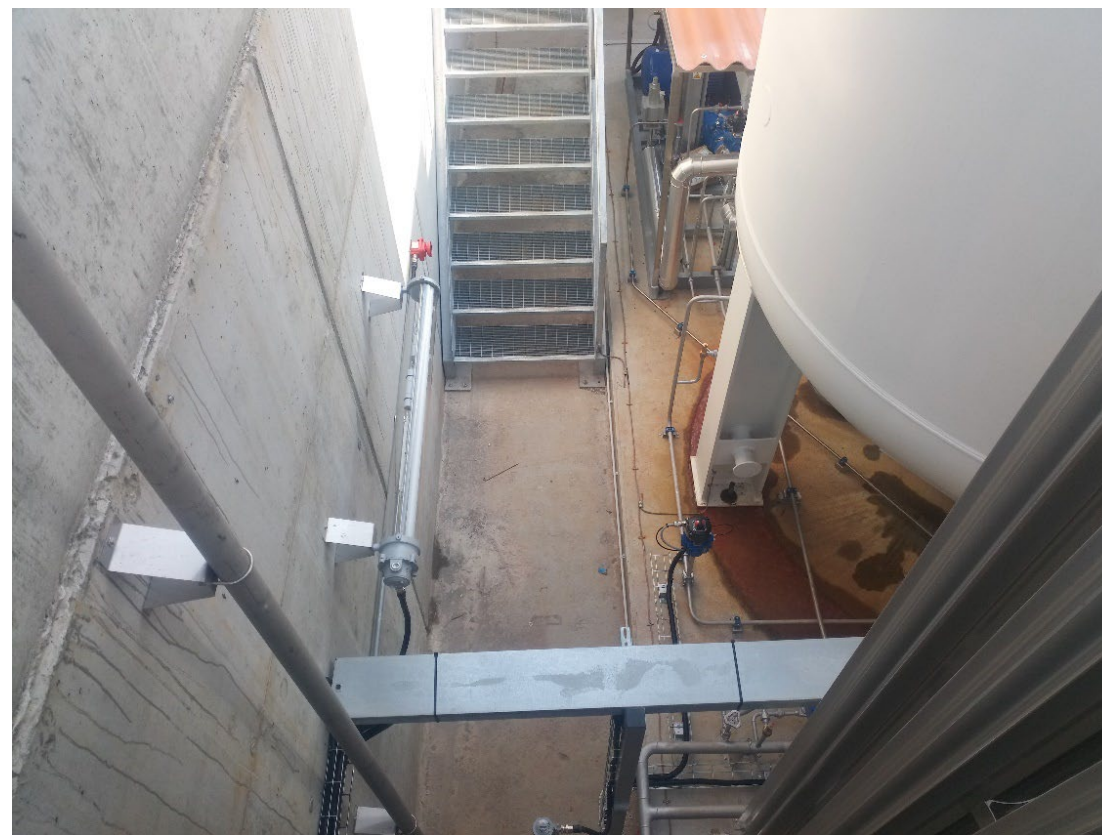
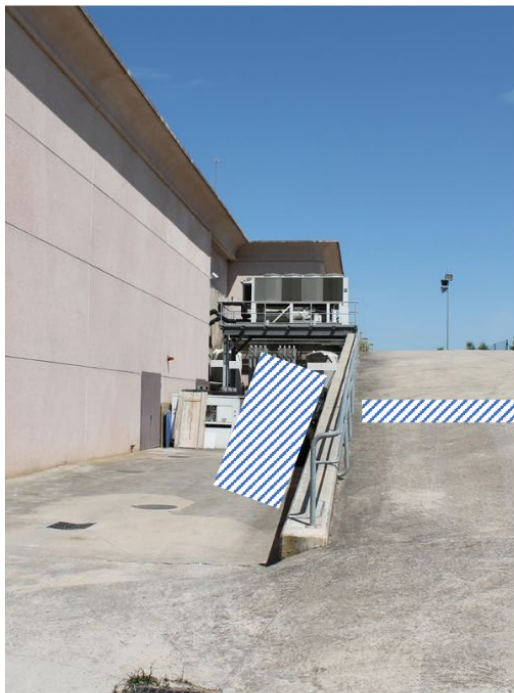
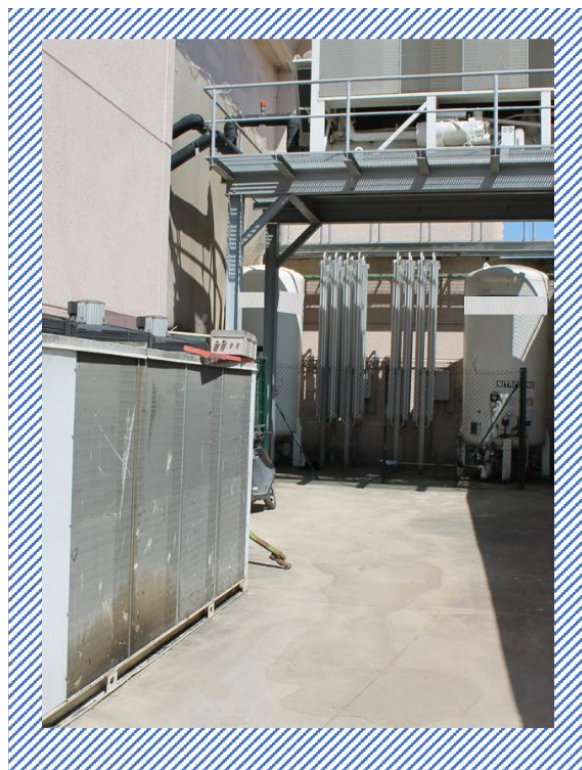
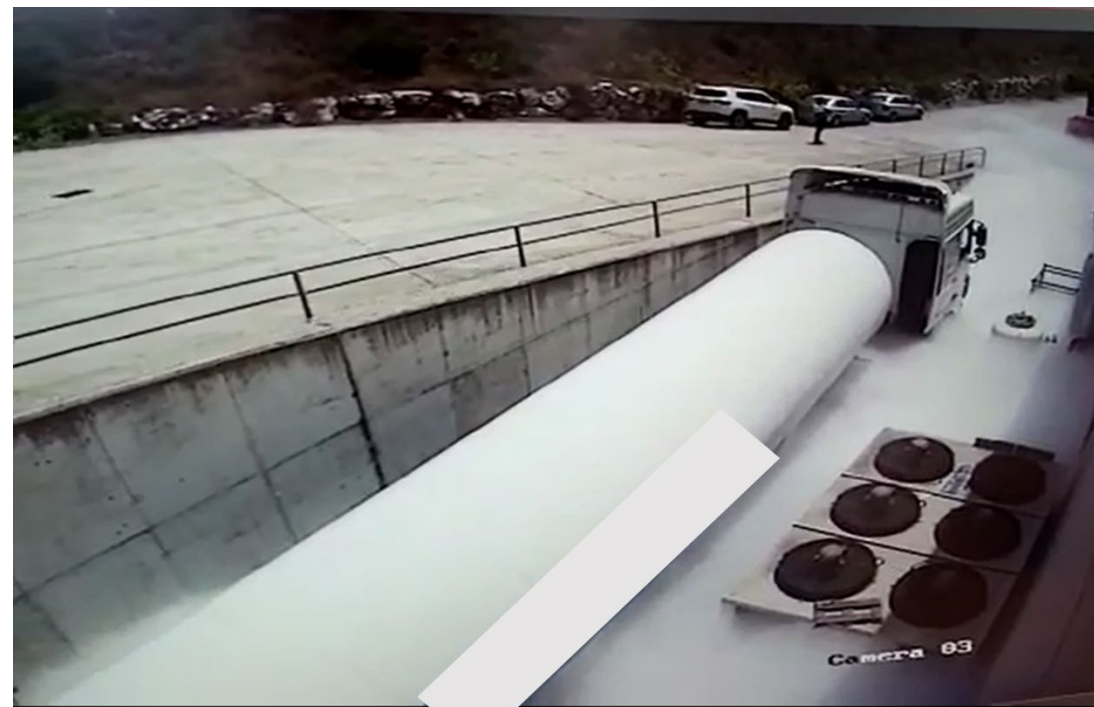
Customer Site – Non standard Installations

- In some cases cryogenic vessels might be installed with "non standard" design, also following requirements stated by competent authorities in technical rules. These extra requirements and "non standard" design impose a dedicated risk assessment to take into consideration possible new emerging risks and define new safety measures. A typical case may be the request from the Fire Brigade to install oxygen or flammable gases vessels in "pits" in order to reduce the effect of a fire or explosion.
- Discussion Points:
 - In case of "non standard" installations, always conduct a detailed risk assessment to define all the necessary preventive/mitigative measures
 - In case of doubts, contact the gas supplier

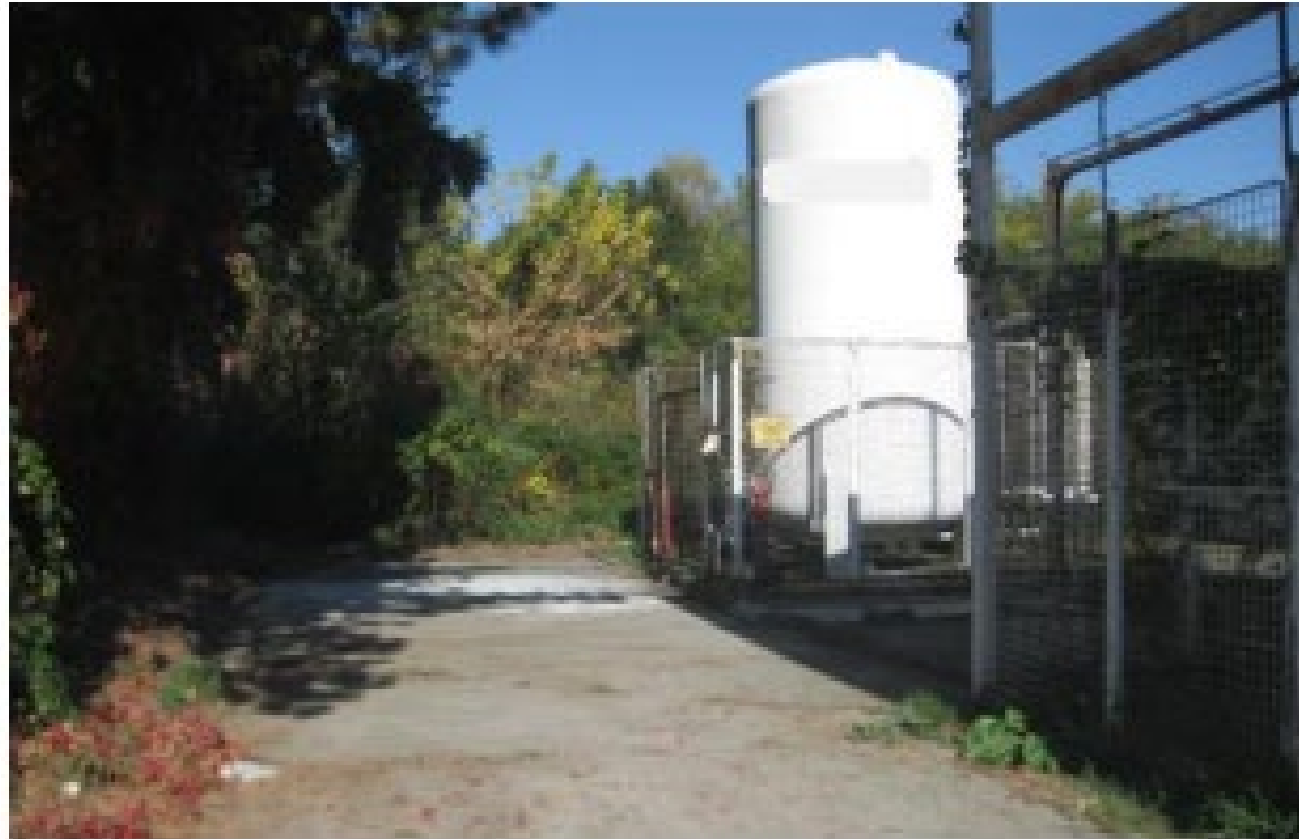
Customer site – Fire during LOX transfilling – Injury

- During transfilling of LOX into the cryogenic vessel at the customer site (hospital), greenery lying all around the transfilling area ignited. Contractor driver tried to stamp out the fire and suffered minor injury (burn) on his legs.
- The driver extinguished the fire with the fire extinguisher
- Discussion points:
 - Areas in proximity of gas installations shall be kept free from foreign materials and clean as organic material can easily ignite in oxygen enriched atmospheres

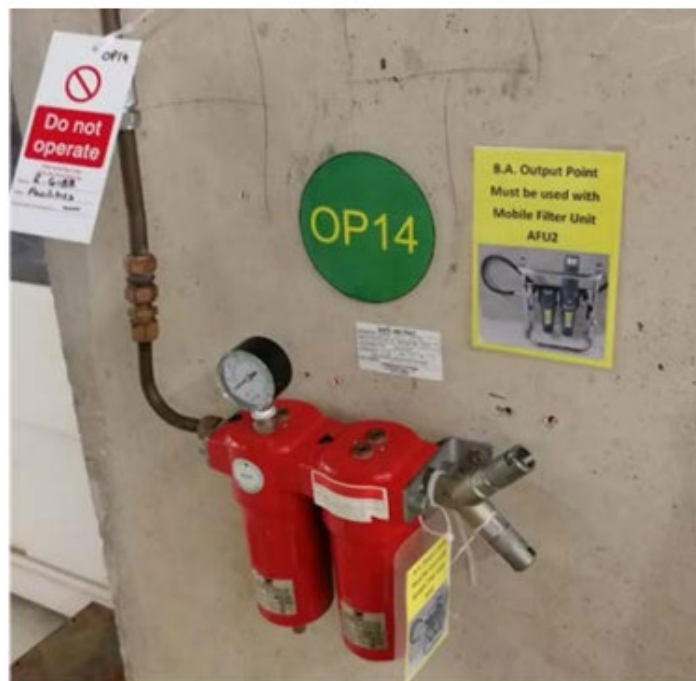
Customer site – Misuse of gas – Near miss

- A pipeline customer discovered high nitrogen content in their Compressed Dry Air (CDA) system during a plant outage of their nitrogen generator plant which supplies both nitrogen and CDA to their factory. The customer noted to the gas company that they sometimes filled breathing air cylinders from the CDA system. The gas company was unaware of this change and confirmed that under no circumstances can this be permitted. Only dedicated systems should be used for Breathing Air.
- No injuries occurred.
- Discussion points:
 - Use equipment only for the intended use; any change shall be notified to the gas company and agreed
 - Clearly mark instrument gas lines with the text "Instrument Gas" and avoid a marking that mentions "Air"!
 - Never use compressed air for breathing purposes. See also EIGA Position Paper 24 “Abuse of Gases

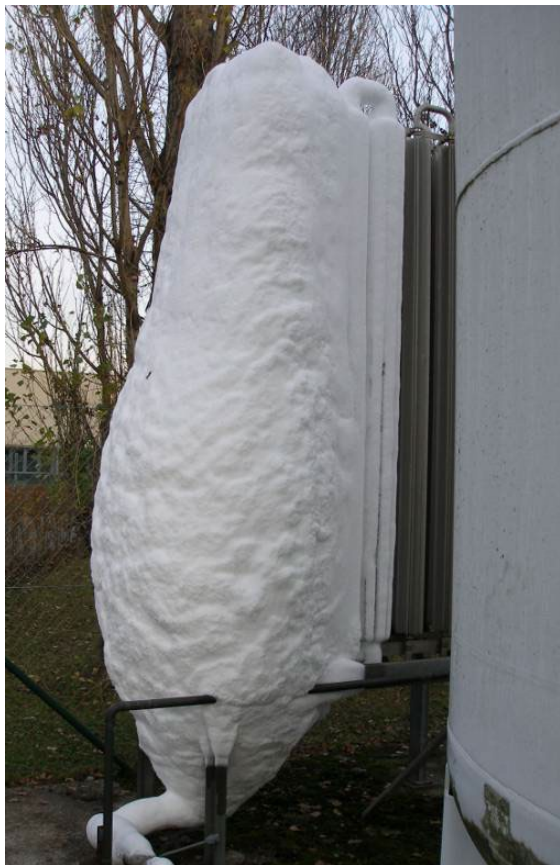
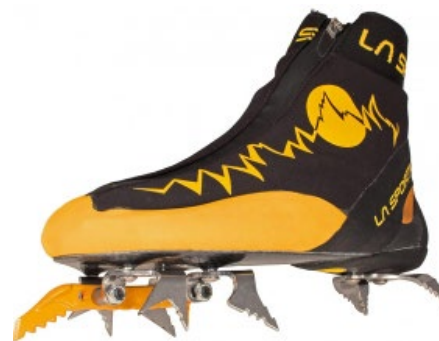
Customer site – Misuse of equipment – Product leak

- At the customer site (hospital) an unknown person tried to test his new climbing shoes by climbing the iced LOX vaporiser. Ice climber damaged the output piping of the vaporiser.
- No injury, leak of oxygen.
- Discussion points:
 - Inform supplier if something abnormal is observed, like ice
 - Gas equipment shall not be misused.

Picture of climbing shoes is illustrative.

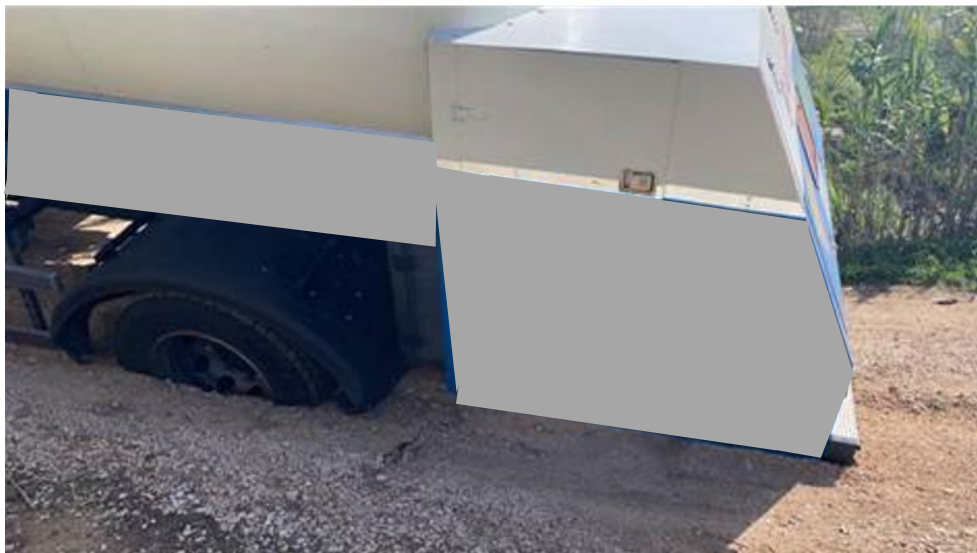
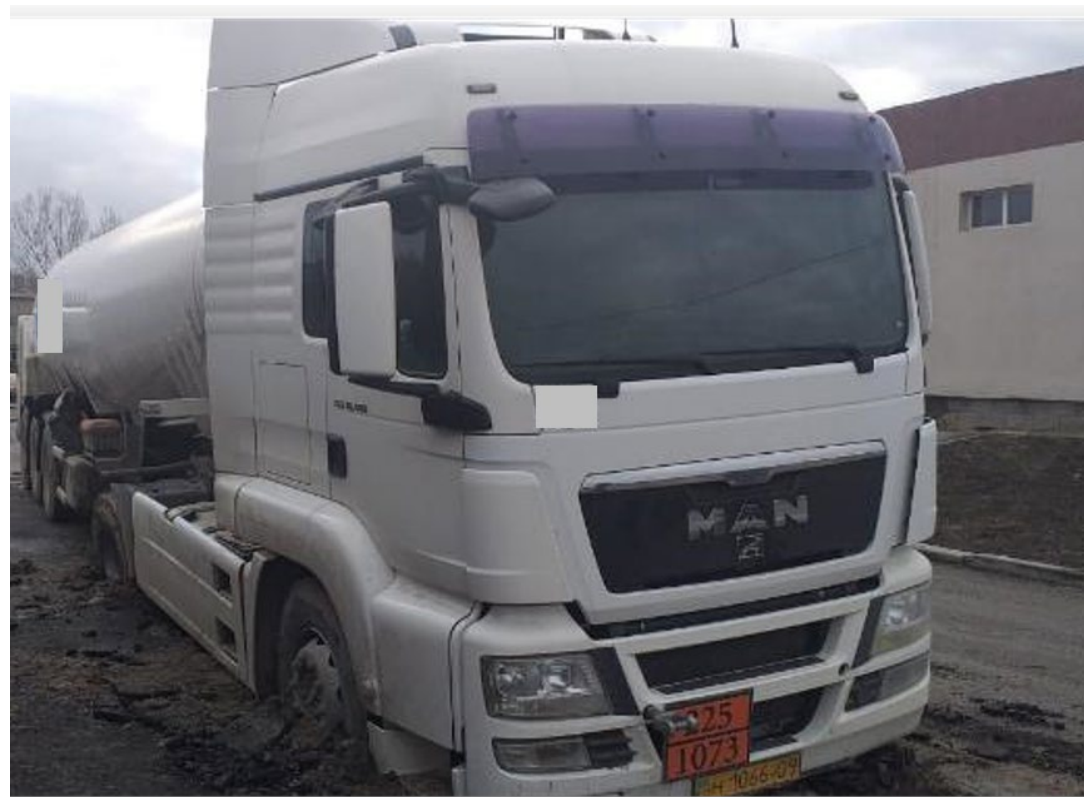
Customer site – Examples of unsuitable access road

- The normal access road was blocked. The customer sent the driver on an alternative road. This road was not designed for heavy loads
- Truck got stuck
- Discussion points:
 - Ensure that access roads to the delivery point are suitable for truck delivery
 - In case of doubts, contact the gas supplier

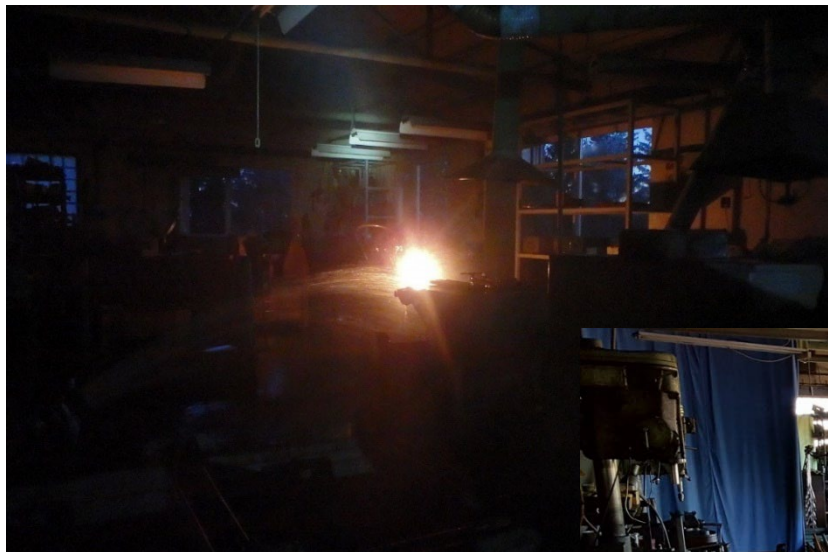
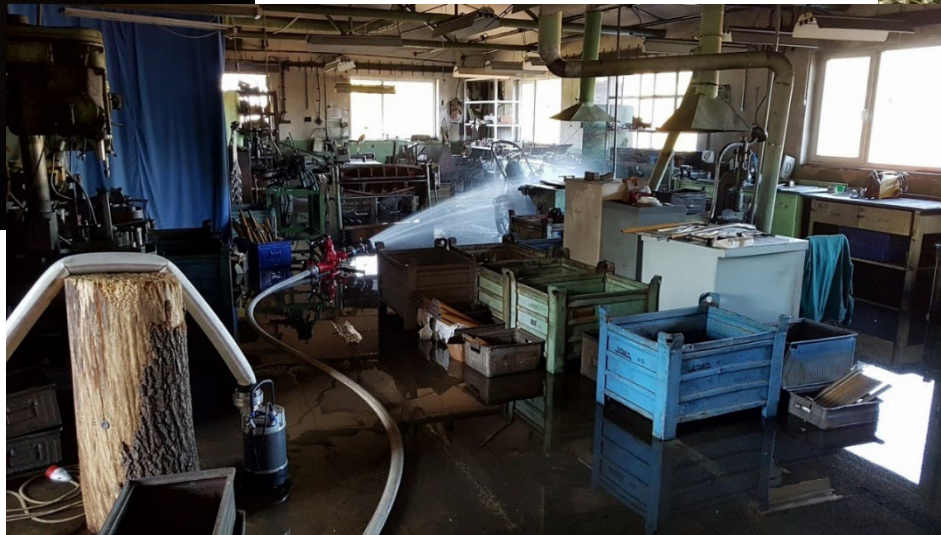
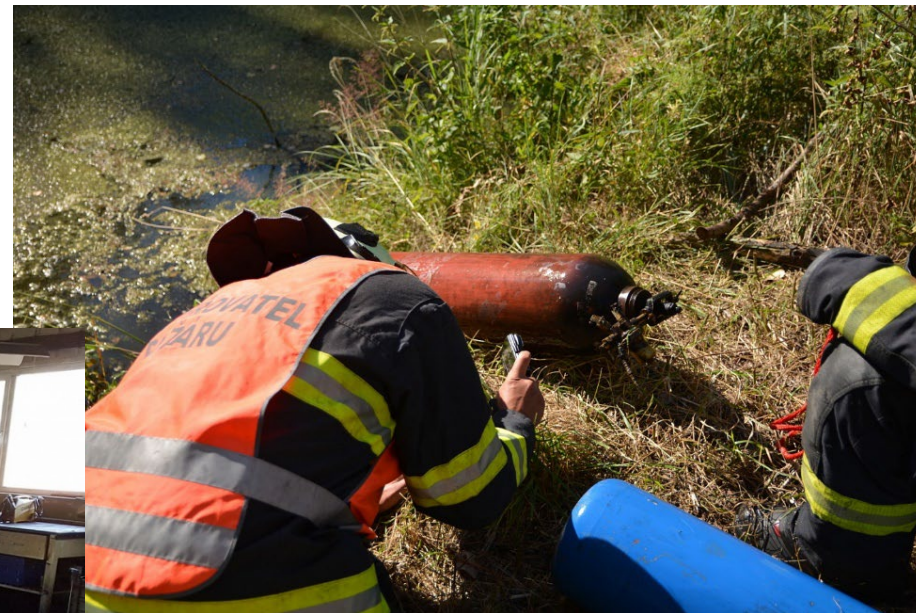
Customer site – Acetylene Fire – Damage

- An acetylene cylinder caught fire at a customer site. The fire occurred during welding activities. The surrounding fire was extinguished by the fire brigade and the cylinder was left to burn out, under constant cooling.

When the fire was extinguished, the cylinder was placed into a water tank. Nobody was injured.

- No flashback arrester was installed on the equipment.
- Discussion points:
 - Ensure that safety equipment required by EIGA and international standards are installed
 - Ensure that flashback arrestors are replaced within the defined time-span defined by the supplier
 - In case of doubts, contact the gas supplier

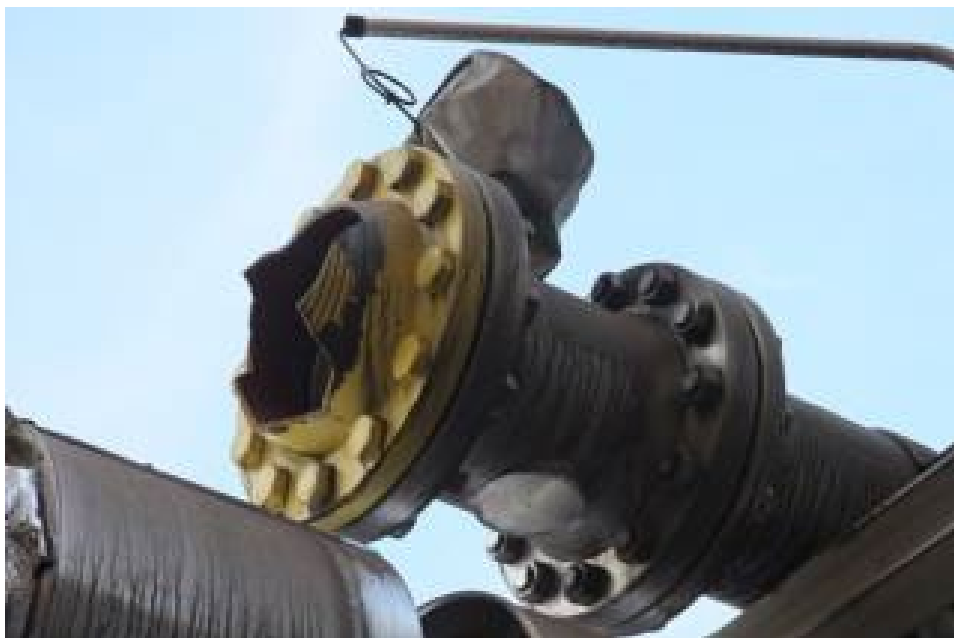
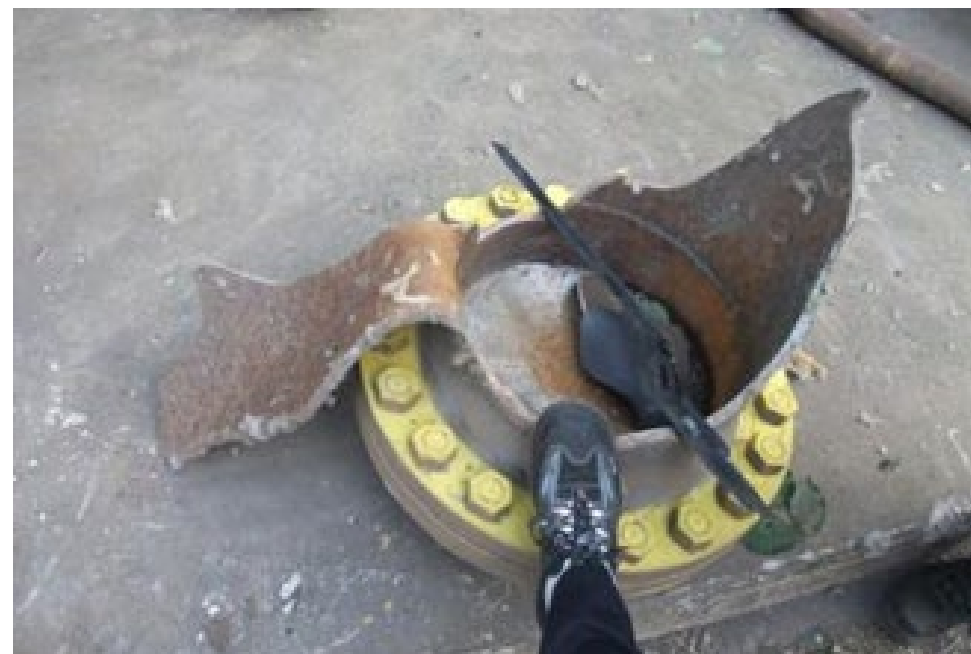
Customer site - Missing protection against cold embrittlement

- A customer supply pipeline ruptured due to cold embrittlement. The ruptured part was the customer's internal installation. The pipeline at customer's side was made of carbon-steel and a Cold Temperature Protection was not installed in the supply set-up. The installation was identified for retrofit of the cold temperature-protection according to new safety standards. Because of ongoing discussion with the customer about suitable timing for the retrofit, this was not yet executed.
- Nobody was injured and the equipment damage was moderate
- Discussion points:
 - Prioritisation of safety related retrofits should be agreed between customer and gas supplier in a timely manner
 - In case of doubts, contact the gas supplier

The risk of cold embrittlement rupture of supply-pipelines has a potential to be fatal

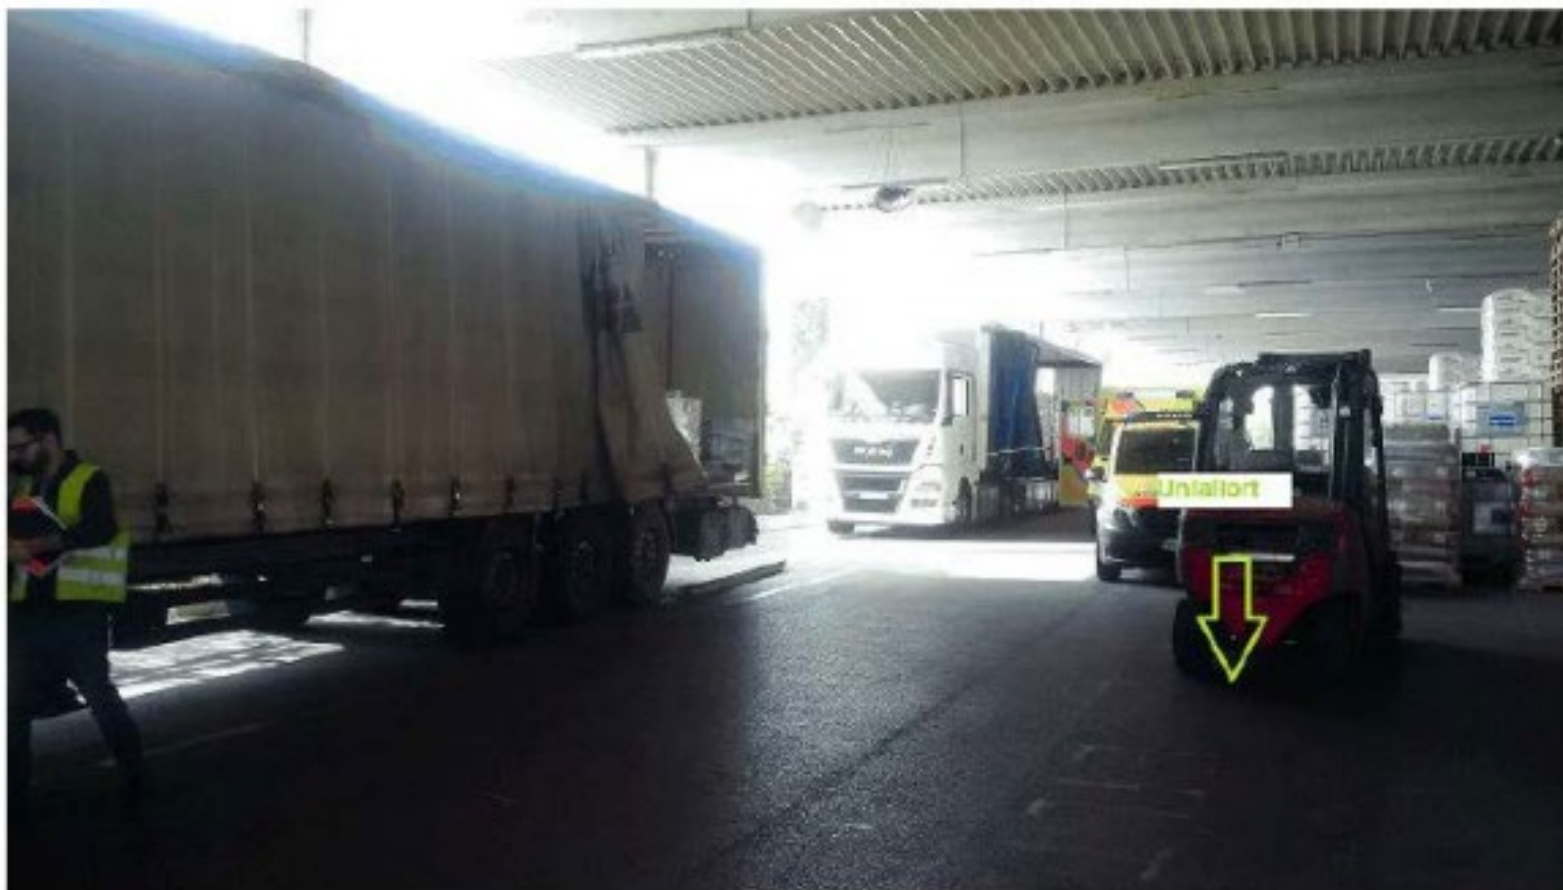
Customer site – Traffic plan – Lost Time Injury

- A cylinder truck driver went to a customer for a delivery. After he had finished his work he had to go to the office to get the delivery note signed by the customer. On his way back to the truck he recognized a busy forklift and therefore he kept an additional buffer distance to it (no footpath was marked on the pavement). After he had passed the customers forklift, he didn't notice that the forklift (not equipped with acoustic warning) reversed and followed his route. He was struck and injured by this forklift.
- He was brought to hospital. He suffered a broken elbow and sprained toes.
- Discussion points:
 - Rules for internal vehicle and pedestrian movements shall be defined with road marks and signage, and people made aware of the rules

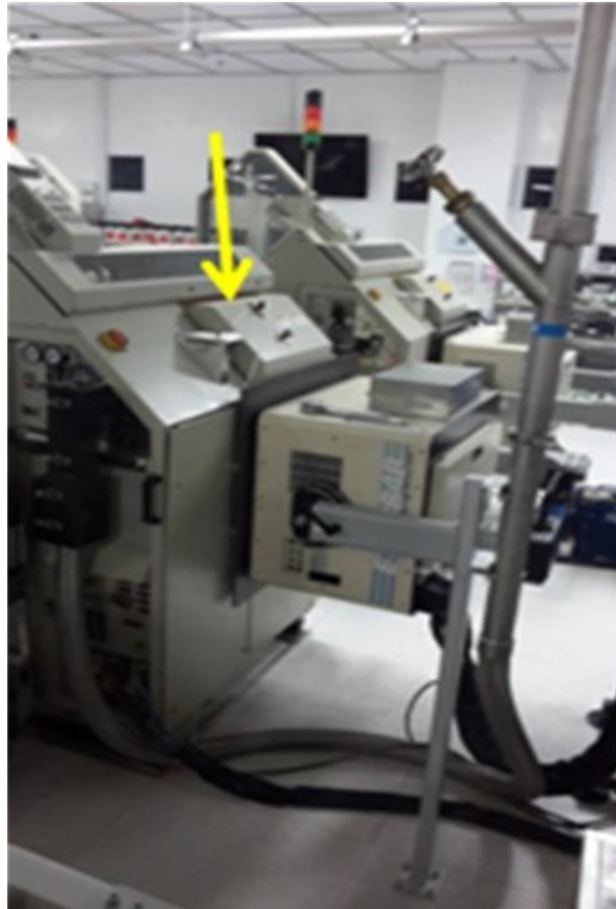
Customer Site – Emergency procedures – Near Miss

- Prior to entering customer production room for work the customer Installation technicians noticed that the rotating lights of Oxygen detector alarm were activated. They verified that the room was Oxygen deficient. The ventilation system was down due to a power supply shutdown and the N2 vent was sent into the room. Measures were taken to increase ventilation and continuous monitoring of O2 level before start of work. After the O2 level went back to a safe level the work began with monitoring of O2 level as well as portable detectors.
- Nobody was injured
- Discussion points:
 - Always respect warning devices and have a clear procedure on how to act in case alarms are activated
 - In case of doubts, contact the gas supplier
