Safety Information **Awareness Package**

Events at Customer Premises

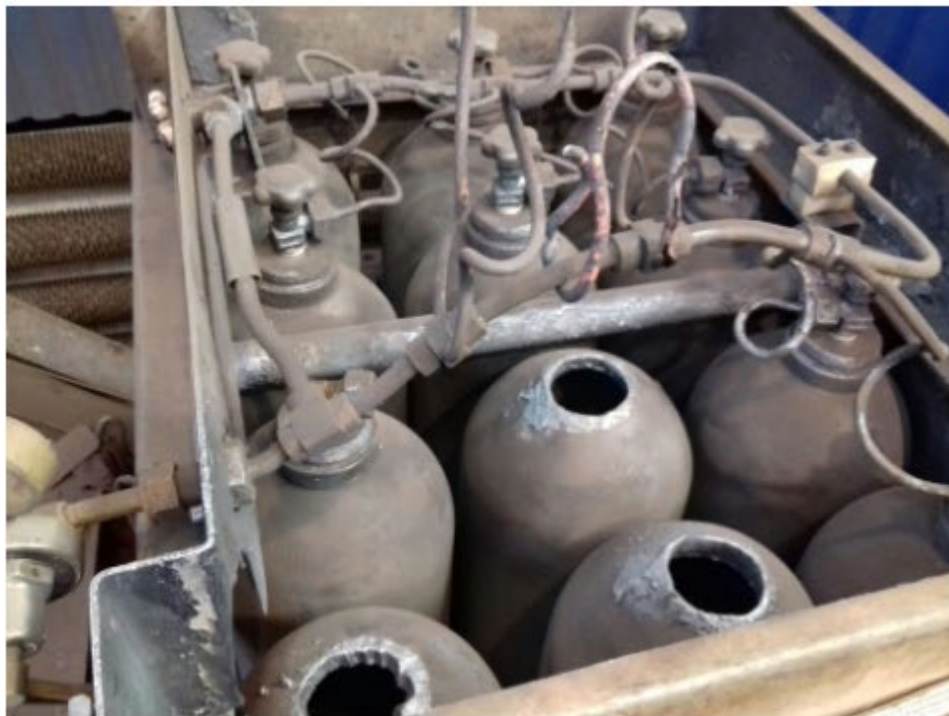
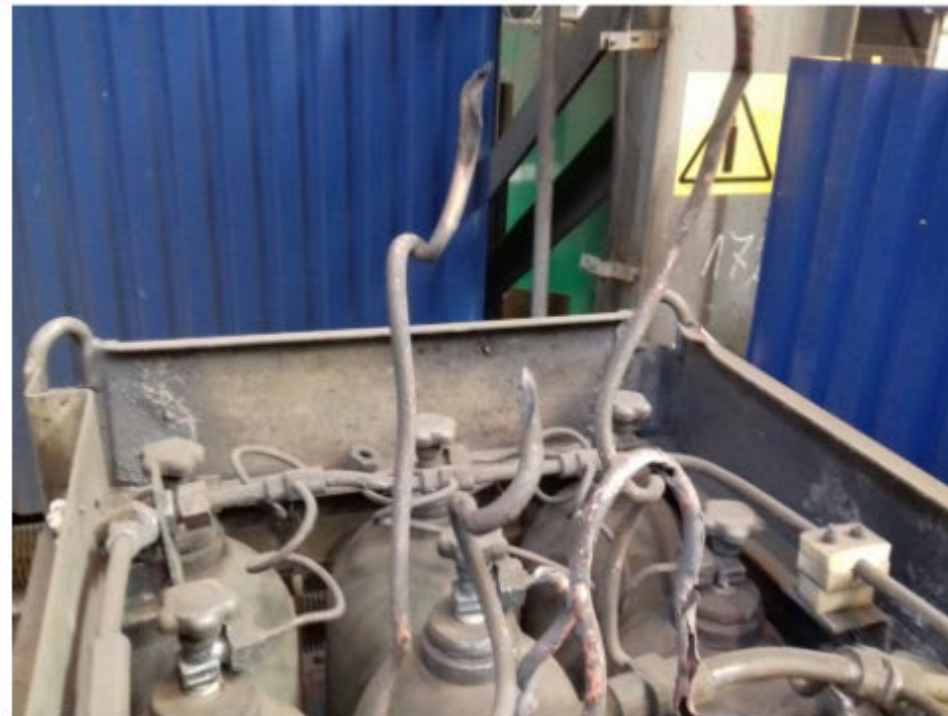
Customer Site – Improper lifting operation

- At a customer site an operator, handling an oxygen bundle using a bridge crane, wrongly connected the hook to a metal part not designed for that purpose. When the operator tried to lift the bundle the hook disconnected, causing the rupture of the collector pipework. The customer reported that to stop the oxygen leakage the operator, wearing a greasy leather glove, tried to close the valve causing an ignition.
- Customer Lost Time Injury due to burns to a hand. Three cylinders of the bundles suffered heavy damage (melting of the cylinder valve, pigtail, cylinder neck and shoulder).
- Discussion points
 - Handle equipment in a correct way and as per design
 - Grease and oxygen have an explosive relationship

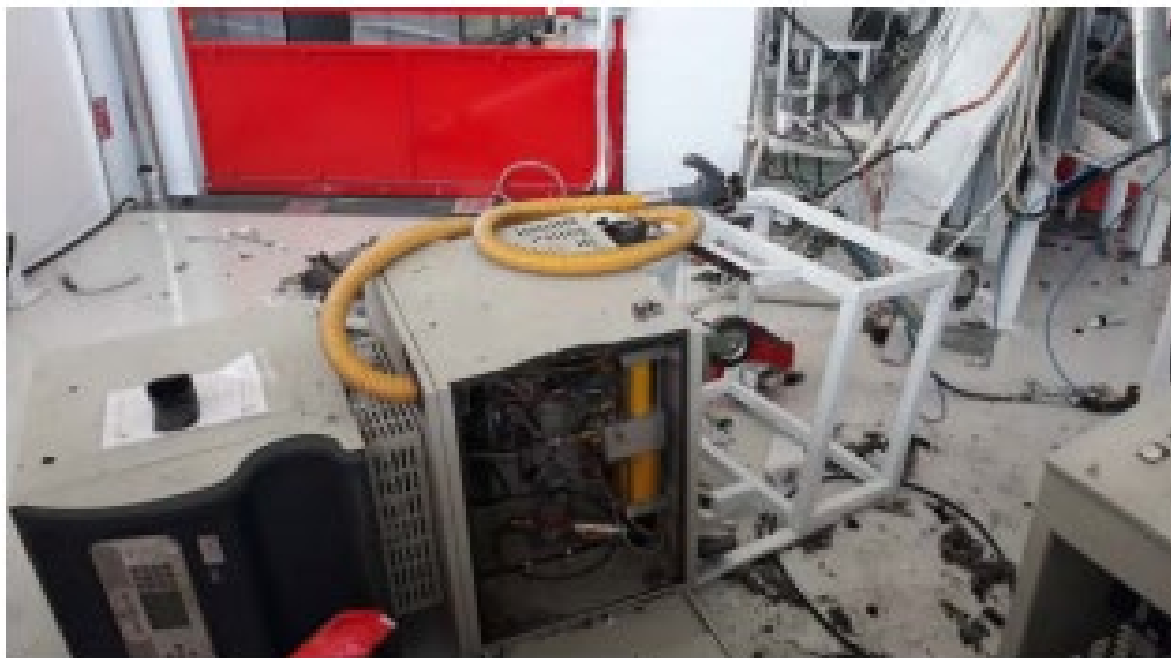
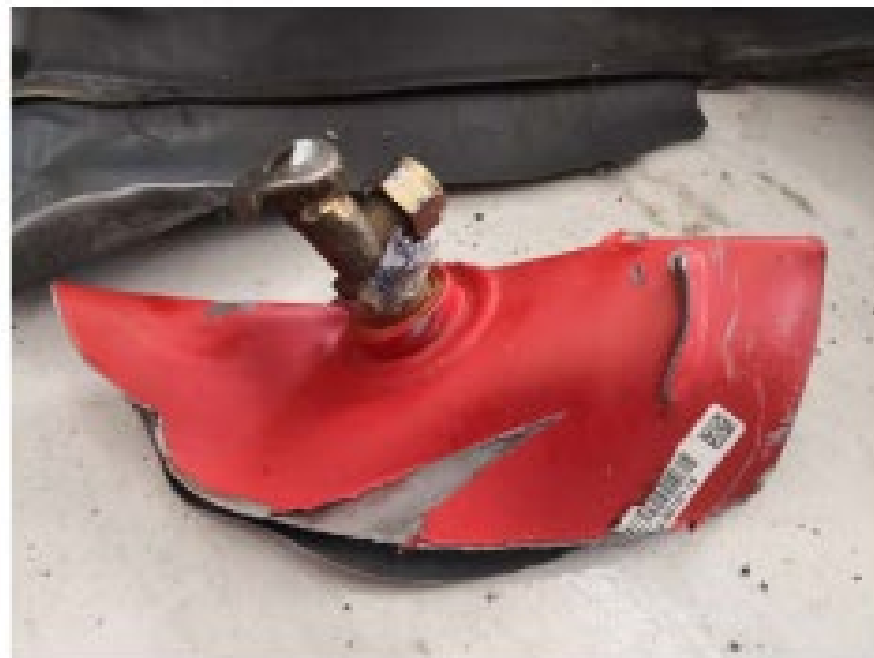
Customer site – Misuse of cylinder - Damage

- At customer premises, a quarter of an hour before the beginning of the working activity, an R290 (propane) cylinder, installed in a customer equipment for filling refrigeration circuits and subjected to heating with heating bands from the night before, exploded.
- Damage to surrounding equipment.
No injuries.
- Discussion points:
 - Follow safe storage instructions provided by the gas company
 - Consider the risks of overheating and hydraulic filling when heating a liquefied compressed gas. When heating is required, ensure that the heating systems provides an effective temperature control
 - In case of doubts, contact the gas supplier

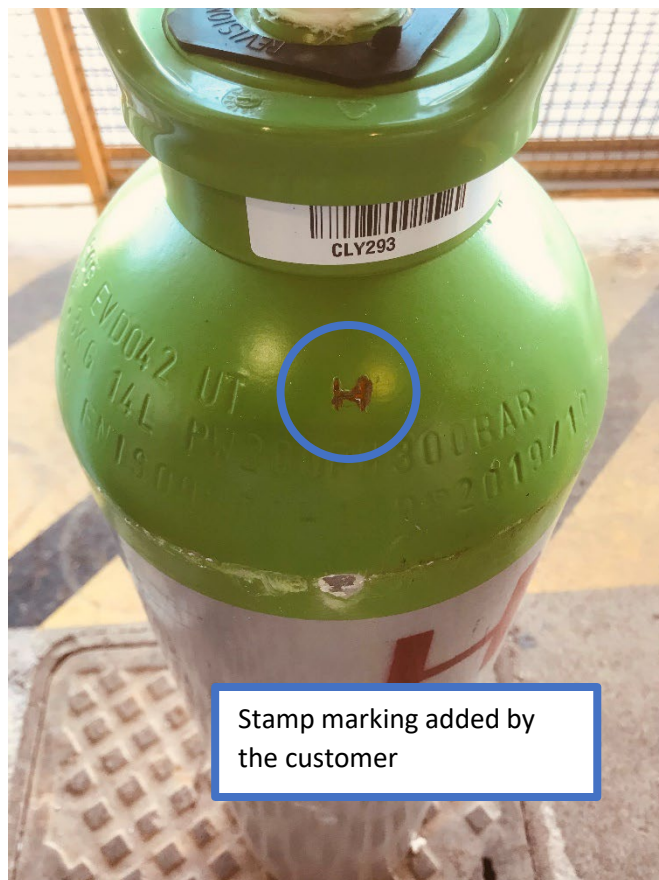
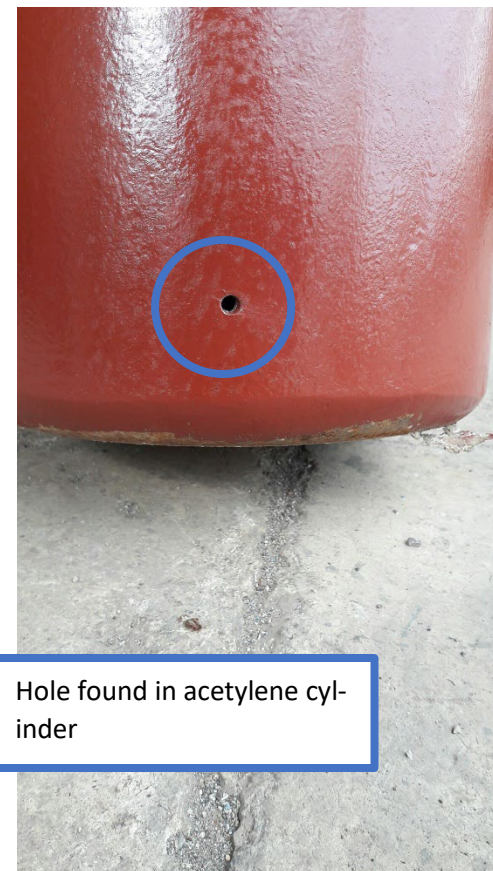
Customer site – Disguised cylinder – Near Miss

- Customer sent a cylinder for filling H₂ mixture. The cylinder was found not to be compatible for H₂ flammable mixtures (no H stamp marking) and returned back to customer. After a while, the customer sent the same cylinder for filling the same mixture. The “H” stamp had been marked meanwhile. The unit discovered the anomaly and stopped the cylinder before filling.

Customer sent an acetylene cylinder for refilling. During preliminary inspection, the plant operator noticed a drilled hole in the bottom part of the cylinder.

- Discussion points:
 - Do not modify cylinders/equipment
 - Use cylinders only for their designed purpose and compatibility

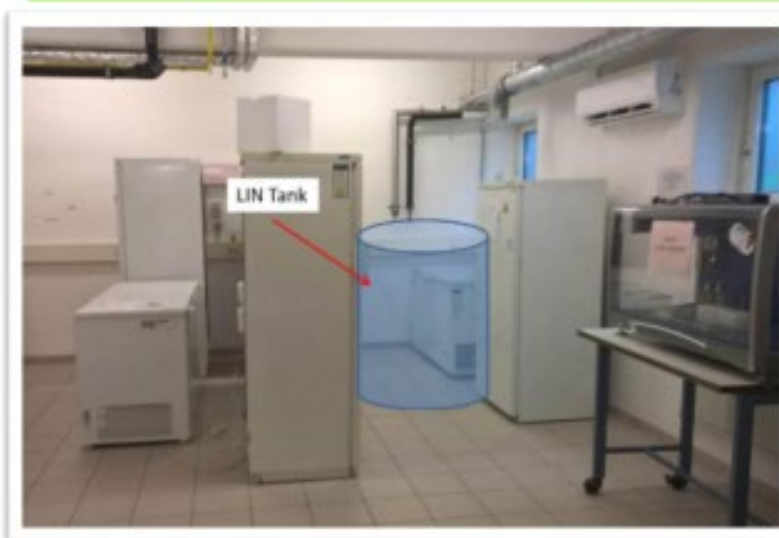
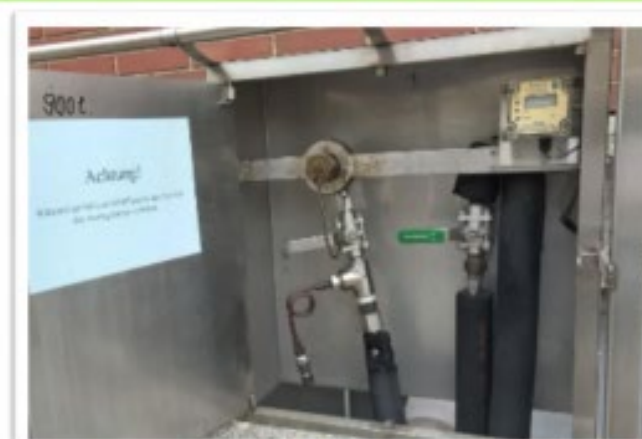
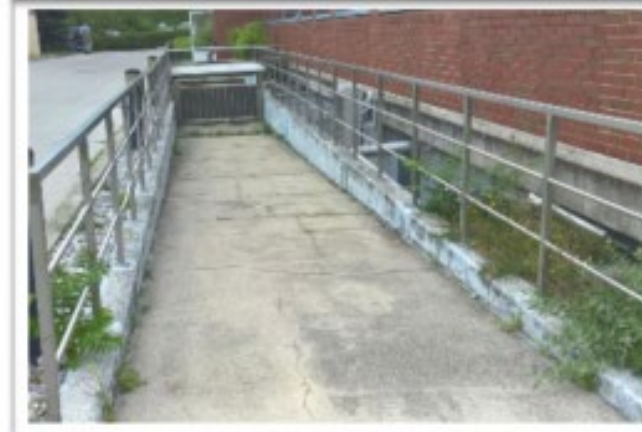
Customer installation – Removed vessel – Near Miss

- A 1000 L liquid nitrogen vessel had been installed in the basement of a customer facility (confined space); the filling connections were outside the building.

The customer removed the tank without informing the liquid nitrogen supplier or implementing any log out – tag out measures at the transfilling point. At the transfilling point there was a cabinet with connections, safety valve and a level indicator, but no pressure indicator.

As the level indicator showed the value “zero” the driver started with the filling procedure and LIN was released to the basement. A confined space atmosphere control sensor switched on an alarm. The driver could not hear it but a customer employee ran out of the building to warn the driver. He stopped the filling procedure.

- Discussion points:
 - Before removing vessels, inform the gas supplier
