Safety Information

Prepared by WG-2 Safety Info 21/26 – November 2026

Cylinder Valves - Design Considerations

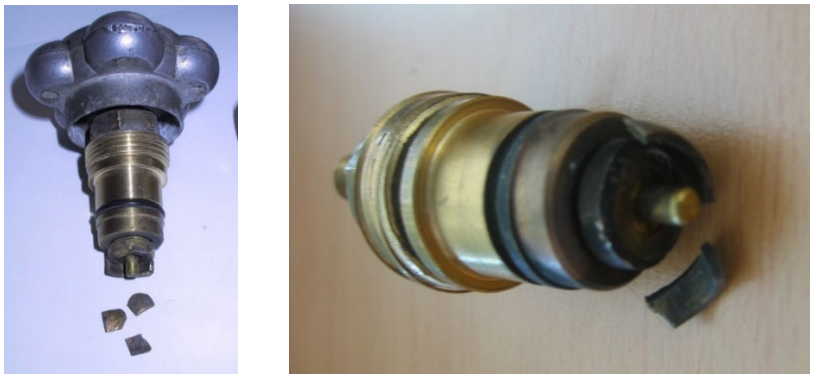
Components that are exposed to high stresses due to gas pressure, including the valve body, gland nut and lower spindle, are at risk of deformation or cracking. In addition, repetitive torque stresses, mechanical fatigue, for example, of the lower spindle and upper spindle, or high assembly stresses, for example, valve stem threads, are also at risk of deformation or cracking. For components potentially subject to stress corrosion, see Sections 3 and 4.

A typical instance of this effect of over stress is the failure of the lower spindle soft seal retention skirt, as illustrated in Figure 1.

Figure 1: broken lower spindle soft seal retention skirt

Individual components, except the valve inlet (that is the thread that connects the valve to the cylinder), should be designed to operate at a safety factor of at least 4, when considering the combined stress of pressure and assembly torque. Particular care should to be taken to prevent stress concentration areas in the design, such as sharp internal corners. Whatever the safety factor, the assembly should comply to fail safe requirements, as described in Section 5.

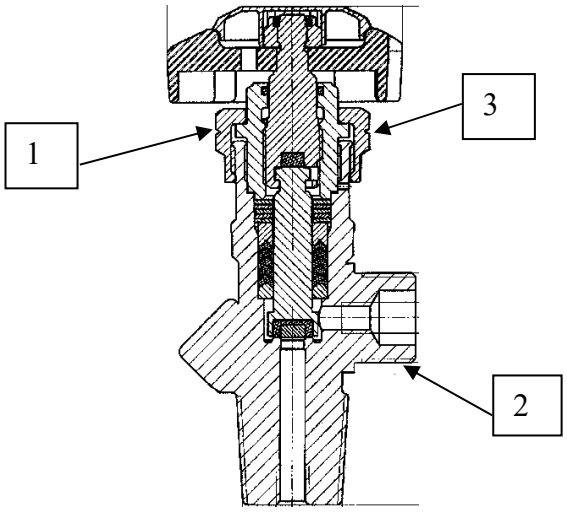
Figure 4: Valve with cover nut

- For some valve designs with a rotating lower spindle, unintended unscrewing of the valve operating mechanism has occurred in service. It can be prevented by having a finer pitch thread on the gland nut (See 1 in Figure 4) than is used on the lower spindle. If this is implemented, even if the gland nut is loosened in service it will not be ejected.

- Valve designs which have the outer spindle thread running in the gland nut (see item 1 in Figure 4) which is itself threaded into the valve body (see item 2 in Figure 4) have a history of loosening the gland nut, following multiple cycles of opening and closing of the valve. High level of gland nut torque alone has not been sufficient to prevent this happening in long-term service. These designs could need the gland nut to have separate mechanical locking, for example by a cover nut (see item 3 in Figure 4), retained by a thread of opposite direction to the gland nut thread.

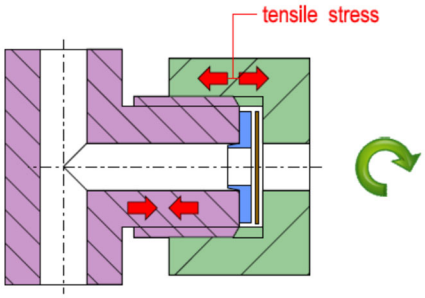
- Pressure relief devices, which have a retaining cap nut in tensile stress (see Figure 5) can lead to cracking, due to stress corrosion cracking or over-stressing, or over torque during assembly.

Figure 5: Cap nut in tensile stress

A change of design to use a cap nut in compressive stress (see Figure 6) will overcome this problem, as long as stress is not higher than allowed for the chosen material (see Section 1).

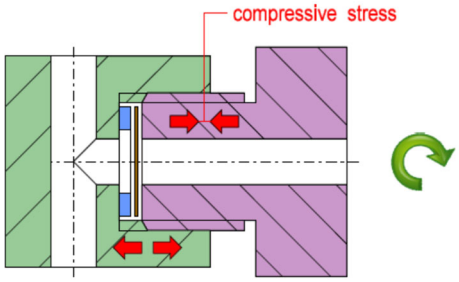
Figure 6: Cap nut in compressive stress

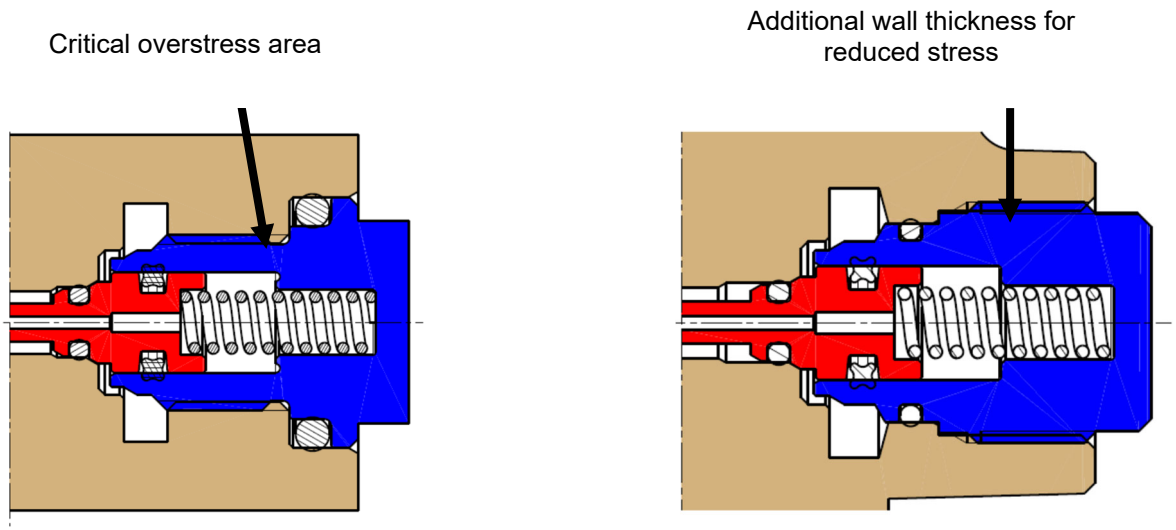
Figure 7: RPV back plug with non-fail safe design (left) and lower stress fail safe design (right)

An example of a fail safe design is given in Figure 7.

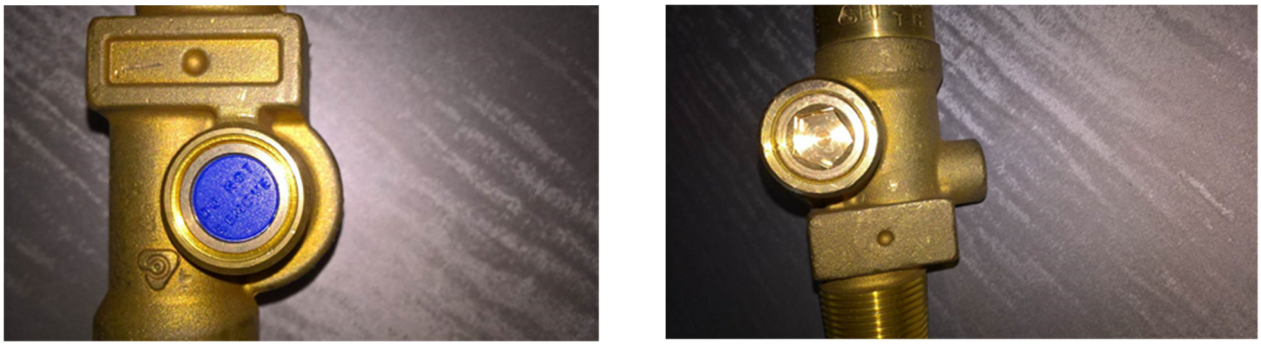
Figure 9: Examples of tamper evident cap and dedicated fixing geometry of a PRV back plug

Whenever possible, it is recommended that external metallic components to the valve, particularly high pressure retaining, are designed to hinder manipulation or to make the manipulation easily visible. Examples include tamper evident caps or the geometry of the residual pressure valve back plug fixing, see Figure 9.
