# **WATER CORROSION OF COMPOSITE CYLINDERS WITH AA6061 LINERS**

**Doc 72/26**

**EUROPEAN INDUSTRIAL GASES ASSOCIATION AISBL**

Published in February 2026

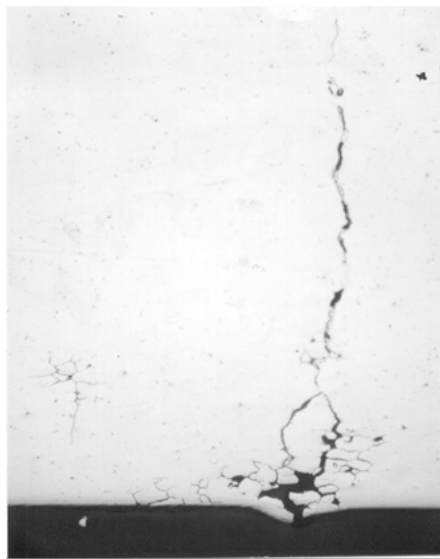
It is clear that a mechanism related to corrosion is in progress. Clear signs of intergranular corrosion were visible at the crack initiation sites for failed cylinders that have been metallographically examined. See Figure 1.

**Figure 1—Hoop-wrapped cylinders (AA6061) fatigue crack initiated from a corrosion pit (Magnification x125)**

This would indicate that the intergranular corrosion created by the contaminants contained in the tap water, introduced local stress raisers that led to premature cyclic loading failures. This intergranular corrosion promotes very high stresses during test pressure cyclic testing, which effectively reduced the fatigue initiation process that usually provides the majority of the cycle life for aluminium alloys. This can be explained by the following:

- Residual chemicals, notably the chloride content in the tap water, have created some pre-existing corrosion related defects due to the alloy's susceptibility, albeit small, to intergranular corrosion; and

- The much thinner wall thickness in a hoop-wrapped or fully-wrapped composite AA6061 cylinder, compared to its seamless counterpart, means that the stress takes a lot less time to propagate the cracks to failure that have been initiated previously.

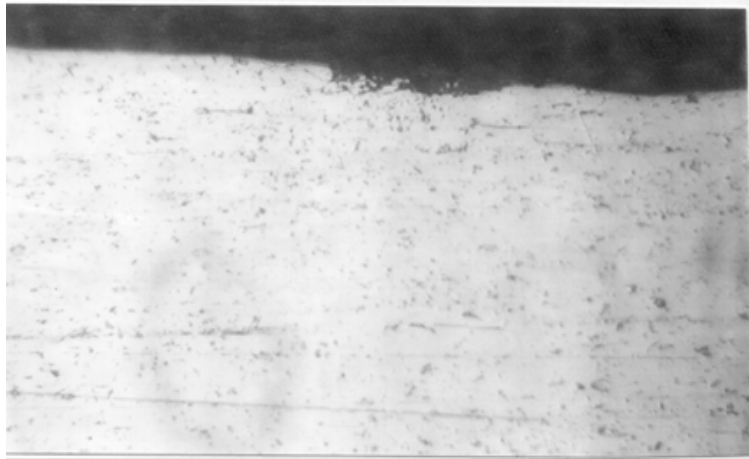
Unlike aluminium alloy cylinders manufactured from some alloys that are totally resistant to intergranular corrosion (e.g., 5283, 7060, etc. according to testing to ISO 7866) cylinders from AA6061 pass the test but exhibit some susceptibility to intergranular corrosion [4]. See Figures 2 and 3.

**Figure 2—AA7060 Cylinder metallographic examination according to the intergranular test as per ISO 7866 (Magnification x 300)**
